# Access Compliance Report

## Public Rights-of-Way

### (Curb Ramps)

Intersection ID: 31435	Main Street: CHEVIOTT_HILL_LN	Cross Street: O_CASEY_LN	Location: NE
ADA ID: E4729E55AC61	Ramp Type: PerpDiag	Initial Pass/Fail: Fail	Overall Compliance: No
Severity Score: 33.75			
Codes/Mitigation Info/Possible Solution		Field Measurements/Component Compliance

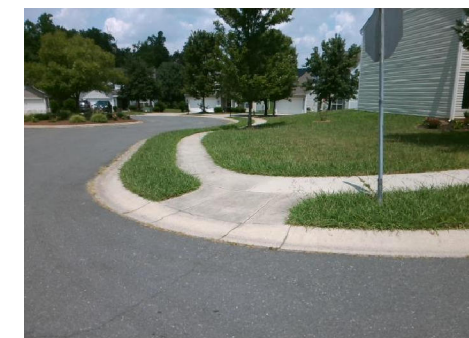
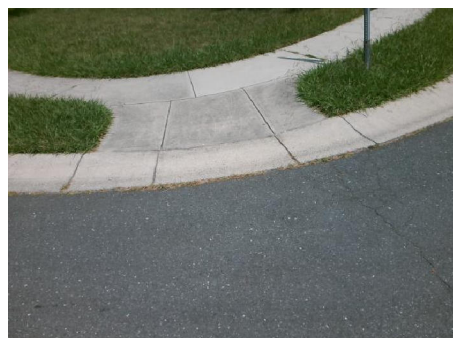
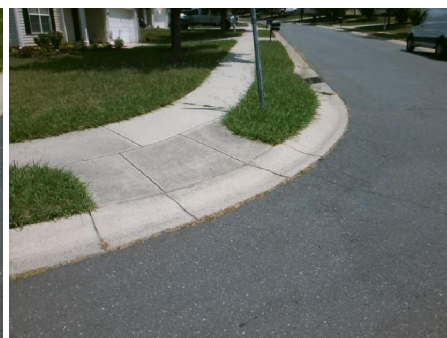
**Not Found, R304.5.1, R304.2.2, R304.5.3**

Compliance	Description	Data	Compliance	Description	Data
N/A	Ramp Length (in)	50.0	No	Ramp Slope (%)	8.6
No	Ramp Width (in)	38.0	No	Ramp XSlope (%)	6.8
N/A	Flare Type LT	N/A	N/A	Flare Type RT	N/A
N/A	Flare Slope LT (%)	N/A	N/A	Flare Slope RT (%)	N/A
N/A	Flare Traversable LT?	N/A	N/A	Flare Traversable RT?	N/A
N/A	Landing Length (in)	N/A	N/A	DWS Provided?	N/A
N/A	Landing Width (in)	N/A	N/A	DWS Contrast?	N/A
N/A	Landing Slope (%)	N/A	N/A	DWS Length (in)	N/A
N/A	Landing X Slope (%)	N/A	N/A	DWS Full Width?	N/A
N/A	Landing Curb? (Y/N)	N/A	N/A	DWS Offset (in)	N/A
N/A	Shared Landing?	N/A			
N/A	Gutter Ponding?	N/A	N/A	Gutter Slope (%)	N/A
N/A	Gutter Lip Ht (in)	N/A	N/A	Gutter X Slope (%)	N/A
N/A	Painted X Walk1?	No	N/A	Painted X Walk2?	No
	X Walk 1 Direction	To W		X Walk 2 Direction	To S
N/A	X Walk 1 Width (in)	N/A	N/A	X Walk 2 Width (in)	N/A
	X Walk 1 Slope (%)	2.9		X Walk 2 Slope (%)	6.1
	X Walk 1 X Slope (%)	5.3		X Walk 2 X Slope (%)	2.6

N/A	Ramp inside XWalk1?	N/A	N/A	Ramp inside XWalk2?	N/A
	Road Slope (%)	5.3	N/A	Clear Space?	N/A
	Road X Slope (%)	3.8	N/A	Clear Space to XWalk (in)	N/A
N/A	Any Obstructions?	N/A	N/A	Storm Grate/Utility Hazard?	N/A
	Obstruction Type			Storm Grate/Utility Type	
		N/A			N/A
			Yes	Surface Condition? (G/P)	Good

**Remove & Replace Curb Ramp With Two New Directional Ramps or Equivalent.**

Total Cost: \$ 3200.00
