Access Compliance Report

Public Rights-of-Way

(Curb Ramps)

Intersection ID: 43182	Main Street: PATTONSBURG_DR	Cross Street: RAVANNA_DR	Location: E
ADA ID: E475D940E3E5	Ramp Type: BlendTrans1	Initial Pass/Fail: Fail	Overall Compliance: No
			Severity Score: 33.75

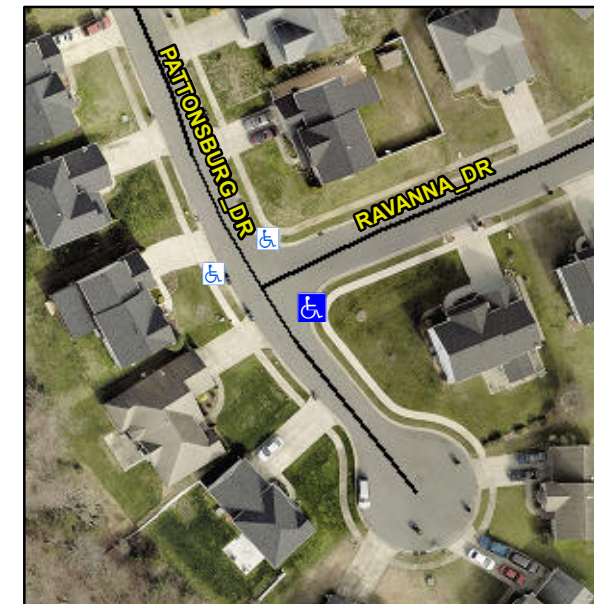
Not Found, R304.5.1, R304.5.3

Compliance	Description	Data	Compliance	Description	Data
N/A	Ramp Length (in)	48.0	Yes	BlendTrans Slope (%)	4.0
No	Ramp Width (in)	37.5	No	BlendTrans XSlope (%)	8.6
N/A	Flare Type LT	N/A	N/A	Flare Type RT	N/A
N/A	Flare Slope LT (%)	N/A	N/A	Flare Slope RT (%)	N/A
N/A	Flare Traversable LT?	N/A	N/A	Flare Traversable RT?	N/A
N/A	Landing Length (in)	N/A	N/A	DWS Provided?	N/A
N/A	Landing Width (in)	N/A	N/A	DWS Contrast?	N/A
N/A	Landing Slope (%)	N/A	N/A	DWS Length (in)	N/A
N/A	Landing X Slope (%)	N/A	N/A	DWS Full Width?	N/A
N/A	Landing Curb? (Y/N)	N/A	N/A	DWS Offset (in)	N/A
N/A	Shared Landing?	N/A			
N/A	Gutter Ponding?	N/A	N/A	Gutter Slope (%)	N/A
N/A	Gutter Lip Ht (in)	N/A	N/A	Gutter X Slope (%)	N/A
N/A	Painted X Walk1?	No	N/A	Painted X Walk2?	No
	X Walk 1 Direction	To N		X Walk 2 Direction	To S
	X Walk 1 Width (in)	N/A		X Walk 2 Width (in)	N/A
	X Walk 1 Slope (%)	7.6		X Walk 2 Slope (%)	1.4
	X Walk 1 X Slope (%)	0.7		X Walk 2 X Slope (%)	8.7

N/A	Ramp inside XWalk1?	N/A	N/A	Ramp inside XWalk2?	N/A
	Road Slope (%)	6.3		Clear Space?	N/A
	Road X Slope (%)	4.4	N/A	Clear Space to XWalk (in)	N/A
N/A	Any Obstructions?	N/A	N/A	Storm Grate/Utility Hazard?	N/A
	Obstruction Type			Storm Grate/Utility Type	
		N/A			N/A
			Yes	Surface Condition? (G/P)	Good
			No	Curb Slope (%)	11.1

Remove & Replace Curb Ramp With Two New Directional Ramps or Equivalent.

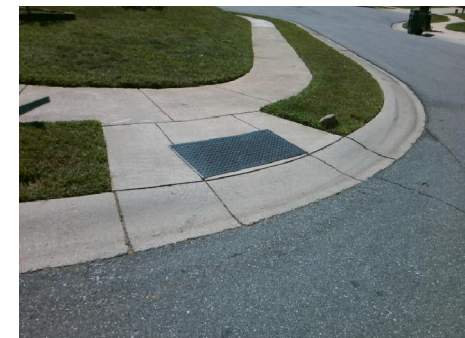
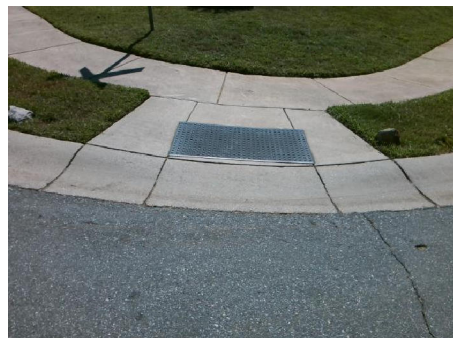
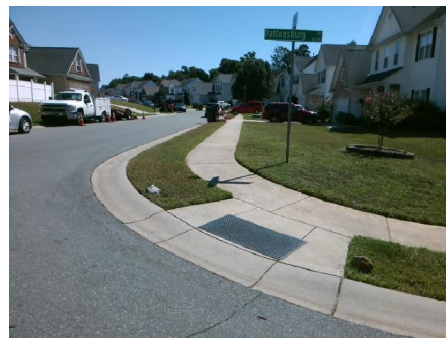
Street 1 Name RAVANNA DR
 Stop Condition-Street 1 StopSign
 Street 2 Name PATTONBURG DR
 Stop Condition-Street 2 None
