Access Compliance Report

Public Rights-of-Way

(Curb Ramps)

Intersection ID: 3512	Main Street: BALATA_CT	Cross Street: SAWGRASS_RIDGE_PL	Location: SW
ADA ID: E479EA86D2EF	Ramp Type: Perp	Initial Pass/Fail: Fail	Overall Compliance: No
		Severity Score: 12.5

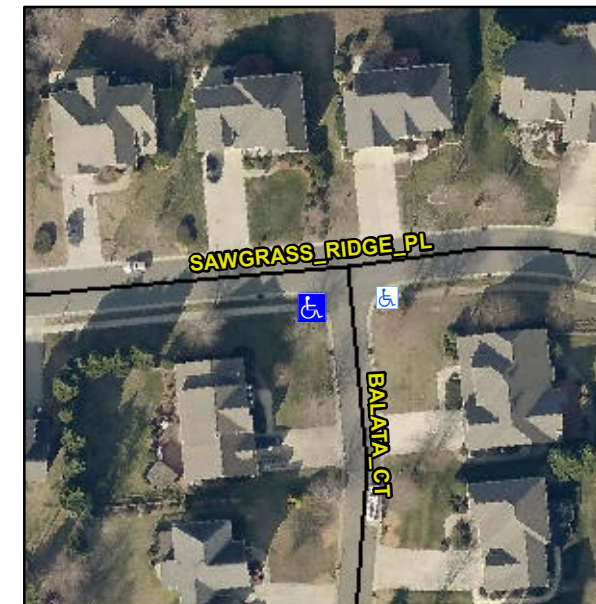
Not Found, R304.2.2

Compliance	Description	Data	Compliance	Description	Data
N/A	Ramp Length (in)	45.0	No	Ramp Slope (%)	8.7
Yes	Ramp Width (in)	58.0	Yes	Ramp XSlope (%)	1.7
N/A	Flare Type LT	N/A	N/A	Flare Type RT	N/A
N/A	Flare Slope LT (%)	N/A	N/A	Flare Slope RT (%)	N/A
N/A	Flare Traversable LT?	N/A	N/A	Flare Traversable RT?	N/A
N/A	Landing Length (in)	N/A	N/A	DWS Provided?	N/A
N/A	Landing Width (in)	N/A	N/A	DWS Contrast?	N/A
N/A	Landing Slope (%)	N/A	N/A	DWS Length (in)	N/A
N/A	Landing X Slope (%)	N/A	N/A	DWS Full Width?	N/A
N/A	Landing Curb? (Y/N)	N/A	N/A	DWS Offset (in)	N/A
N/A	Shared Landing?	N/A			
N/A	Gutter Ponding?	N/A	N/A	Gutter Slope (%)	N/A
N/A	Gutter Lip Ht (in)	N/A	N/A	Gutter X Slope (%)	N/A
N/A	Painted X Walk1?	No	N/A	Painted X Walk2?	N/A
	X Walk 1 Direction	To E		X Walk 2 Direction	N/A
N/A	X Walk 1 Width (in)	N/A	N/A	X Walk 2 Width (in)	N/A
	X Walk 1 Slope (%)	3.5		X Walk 2 Slope (%)	N/A
	X Walk 1 X Slope (%)	1.9		X Walk 2 X Slope (%)	N/A

N/A	Ramp inside XWalk1?	N/A	N/A	Ramp inside XWalk2?	N/A
	Road Slope (%)	N/A	N/A	Clear Space?	N/A
	Road X Slope (%)	N/A	N/A	Clear Space to XWalk (in)	N/A
N/A	Any Obstructions?	N/A	N/A	Storm Grate/Utility Hazard?	N/A
	Obstruction Type			Storm Grate/Utility Type	
		N/A			N/A
			Yes	Surface Condition? (G/P)	Good

Remove & Replace Entire Ramp.
