# Access Compliance Report

## Public Rights-of-Way

| Intersection ID: 53930 | Main Street: STARNES RANDALL RD | Cross Street: BRITTONDALE LN | Location: W |
| ADA ID: E484DE18B8AB | Ramp Type: Perp | Initial Pass/Fail: Fail | Overall Compliance: No |

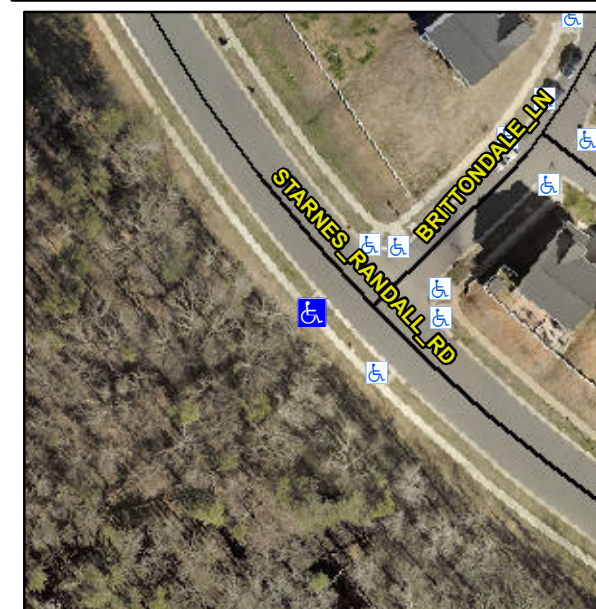
| Severity Score: 21.25 | | | |

**Not Found, R304.5.1, R304.5.3**

| Compliance | Description | Data | Compliance | Description | Data |
|---|---|---|---|---|---|
| N/A | Ramp Length (in) | 84.5 | Yes | Ramp Slope (%) | 6.4 |
| No | Ramp Width (in) | 47.0 | No | Ramp XSlope (%) | 5.3 |

**Remove & Replace Entire Ramp.**

Total Cost: \$ 1850.00
