Access Compliance Report

Public Rights-of-Way

(Curb Ramps)

Intersection ID: 8111	Main Street: CINDERELLA_RD	Cross Street: THORNWOOD_RD	Location: NW
ADA ID: E4861A81A8F8	Ramp Type: Perp	Initial Pass/Fail: Fail	Overall Compliance: No
		Severity Score: 10

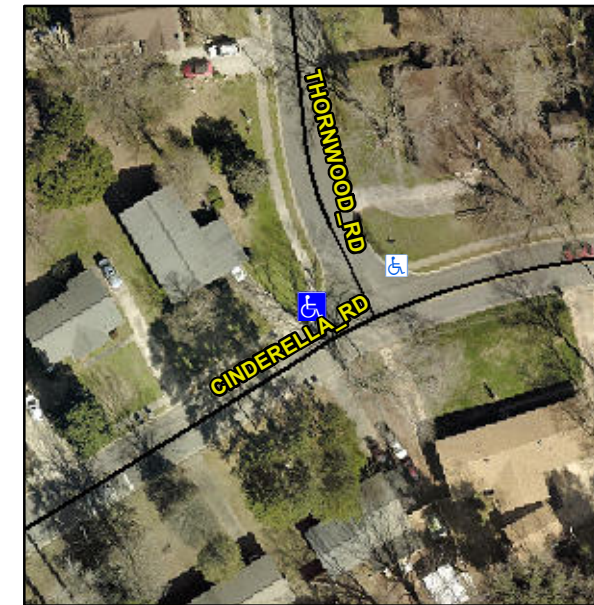
Not Found, R304.5.1, R304.5.3

Compliance	Description	Data	Compliance	Description	Data
N/A	Ramp Length (in)	61.0	Yes	Ramp Slope (%)	5.7
No	Ramp Width (in)	47.0	No	Ramp XSlope (%)	2.4
N/A	Flare Type LT	N/A	N/A	Flare Type RT	N/A
N/A	Flare Slope LT (%)	N/A	N/A	Flare Slope RT (%)	N/A
N/A	Flare Traversable LT?	N/A	N/A	Flare Traversable RT?	N/A
N/A	Landing Length (in)	N/A	N/A	DWS Provided?	N/A
N/A	Landing Width (in)	N/A	N/A	DWS Contrast?	N/A
N/A	Landing Slope (%)	N/A	N/A	DWS Length (in)	N/A
N/A	Landing X Slope (%)	N/A	N/A	DWS Full Width?	N/A
N/A	Landing Curb? (Y/N)	N/A	N/A	DWS Offset (in)	N/A
N/A	Shared Landing?	N/A			
N/A	Gutter Ponding?	N/A	N/A	Gutter Slope (%)	N/A
N/A	Gutter Lip Ht (in)	2.5	N/A	Gutter X Slope (%)	N/A
N/A	Painted X Walk1?	No	N/A	Painted X Walk2?	N/A
	X Walk 1 Direction	To E		X Walk 2 Direction	N/A
N/A	X Walk 1 Width (in)	N/A	N/A	X Walk 2 Width (in)	N/A
	X Walk 1 Slope (%)	6.3		X Walk 2 Slope (%)	N/A
	X Walk 1 X Slope (%)	3.2		X Walk 2 X Slope (%)	N/A

N/A	Ramp inside XWalk1?	N/A	N/A	Ramp inside XWalk2?	N/A
	Road Slope (%)	N/A	N/A	Clear Space?	N/A
	Road X Slope (%)	N/A	N/A	Clear Space to XWalk (in)	N/A
N/A	Any Obstructions?	N/A	N/A	Storm Grate/Utility Hazard?	N/A
	Obstruction Type			Storm Grate/Utility Type	
		N/A			N/A
			Yes	Surface Condition? (G/P)	Good

Remove & Replace Entire Ramp.
