# Access Compliance Report

## Public Rights-of-Way

### (Curb Ramps)

| Intersection ID: 29354 | Main Street: OSAGE_CR | Cross Street: TETON_TL | Location: SE |

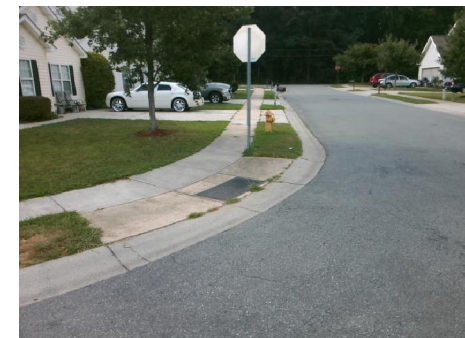
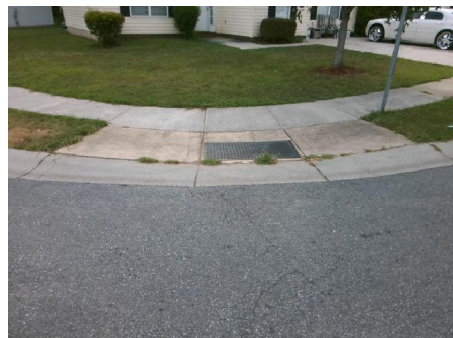
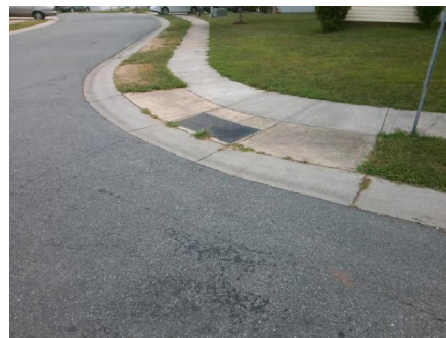
| ADA ID: E49388E9780A | Ramp Type: BlendTrans1 | Initial Pass/Fail: Pass | Overall Compliance: No |
| | | Severity Score: 7.75 | |

**CURB GAP 2.0**

**Not Found, R304.5.3, R304.2.1, R304.2.2-Perp, R304.3.2-Para, R305.1.4, R305.2, R304.5.4**

**Remove & Replace Curb Ramp With Two New Directional Ramps or Equivalent. Remove & Replace Gutter.**
