Access Compliance Report

Public Rights-of-Way

(Curb Ramps)

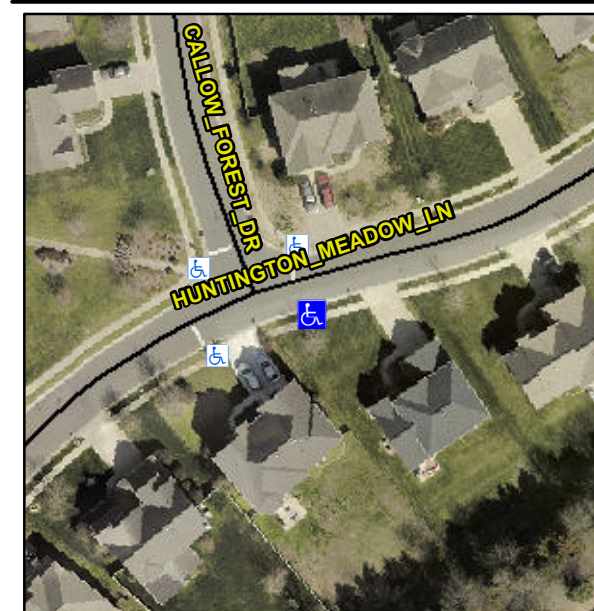
Intersection ID: 43656	Main Street: HUNTINGTON_MEADOW_LN	Cross Street: CALLOW_FOREST_DR	Location: SE
ADA ID: E4991270B178	Ramp Type: Perp	Initial Pass/Fail: Fail	Overall Compliance: No
Severity Score: 10			
Codes/Mitigation Info/Possible Solution		Field Measurements/Component Compliance

Not Found, R304.5.1, R304.5.3

Compliance	Description	Data	Compliance	Description	Data
N/A	Ramp Length (in)	47.0	Yes	Ramp Slope (%)	7.7
No	Ramp Width (in)	44.0	No	Ramp XSlope (%)	2.2
N/A	Flare Type LT	N/A	N/A	Flare Type RT	N/A
N/A	Flare Slope LT (%)	N/A	N/A	Flare Slope RT (%)	N/A
N/A	Flare Traversable LT?	N/A	N/A	Flare Traversable RT?	N/A
N/A	Landing Length (in)	N/A	N/A	DWS Provided?	N/A
N/A	Landing Width (in)	N/A	N/A	DWS Contrast?	N/A
N/A	Landing Slope (%)	N/A	N/A	DWS Length (in)	N/A
N/A	Landing X Slope (%)	N/A	N/A	DWS Full Width?	N/A
N/A	Landing Curb? (Y/N)	N/A	N/A	DWS Offset (in)	N/A
N/A	Shared Landing?	N/A			
N/A	Gutter Ponding?	N/A	N/A	Gutter Slope (%)	N/A
N/A	Gutter Lip Ht (in)	N/A	N/A	Gutter X Slope (%)	N/A
N/A	Painted X Walk1?	No	N/A	Painted X Walk2?	N/A
	X Walk 1 Direction	To N		X Walk 2 Direction	N/A
N/A	X Walk 1 Width (in)	N/A	N/A	X Walk 2 Width (in)	N/A
	X Walk 1 Slope (%)	4.2		X Walk 2 Slope (%)	N/A
	X Walk 1 X Slope (%)	1.5		X Walk 2 X Slope (%)	N/A

Remove & Replace Entire Ramp.
