# Access Compliance Report

## Public Rights-of-Way

### (Curb Ramps)

Intersection ID: 4180	Main Street: DAVID_COX_RD	Cross Street: HARRIS_POINTE_DR	Location: SE
ADA ID: E4A52365A7AC	Ramp Type: Perp	Initial Pass/Fail: Fail	Overall Compliance: No
		Severity Score: 25

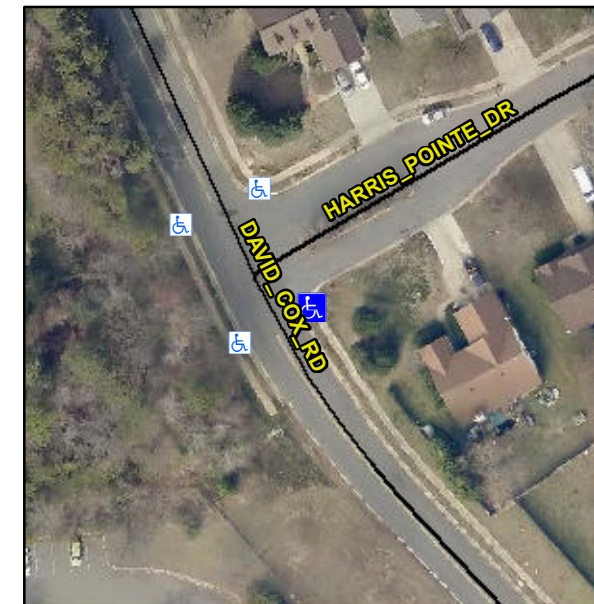
Compliance	Description	Data	Compliance	Description	Data
N/A	Ramp Length (in)	52.5	No	Ramp Slope (%)	10.0
Yes	Ramp Width (in)	48.0	No	Ramp XSlope (%)	6.2
N/A	Flare Type LT	N/A	N/A	Flare Type RT	N/A
N/A	Flare Slope LT (%)	N/A	N/A	Flare Slope RT (%)	N/A
N/A	Flare Traversable LT?	N/A	N/A	Flare Traversable RT?	N/A
N/A	Landing Length (in)	N/A	N/A	DWS Provided?	N/A
N/A	Landing Width (in)	N/A	N/A	DWS Contrast?	N/A
N/A	Landing Slope (%)	N/A	N/A	DWS Length (in)	N/A
N/A	Landing X Slope (%)	N/A	N/A	DWS Full Width?	N/A
N/A	Landing Curb? (Y/N)	N/A	N/A	DWS Offset (in)	N/A
N/A	Shared Landing?	N/A			
N/A	Gutter Ponding?	N/A	N/A	Gutter Slope (%)	N/A
N/A	Gutter Lip Ht (in)	N/A	N/A	Gutter X Slope (%)	N/A
N/A	Painted X Walk1?	No	N/A	Painted X Walk2?	N/A
	X Walk 1 Direction	To N		X Walk 2 Direction	N/A
N/A	X Walk 1 Width (in)	N/A	N/A	X Walk 2 Width (in)	N/A
	X Walk 1 Slope (%)	5.3		X Walk 2 Slope (%)	N/A
	X Walk 1 X Slope (%)	7.1		X Walk 2 X Slope (%)	N/A

N/A	Ramp inside XWalk1?	N/A	N/A	Ramp inside XWalk2?	N/A
	Road Slope (%)	N/A	N/A	Clear Space?	N/A
	Road X Slope (%)	N/A	N/A	Clear Space to XWalk (in)	N/A
N/A	Any Obstructions?	N/A	N/A	Storm Grate/Utility Hazard?	N/A
	Obstruction Type			Storm Grate/Utility Type	
		N/A			N/A
			Yes	Surface Condition? (G/P)	Good

Possible Solutions:

**Remove & Replace Entire Ramp.**

**R304.2.2, R304.5.3**
