# Access Compliance Report

## Public Rights-of-Way

### (Curb Ramps)

Intersection ID: 14432	Main Street: AMHERST_PL	Cross Street: QUEENS_RD	Location: SW
ADA ID: E4A5D96F208D	Ramp Type: Directional1	Initial Pass/Fail: Fail	Overall Compliance: No
Severity Score: 37.5			
Codes/Mitigation Info/Possible Solution		Field Measurements/Component Compliance

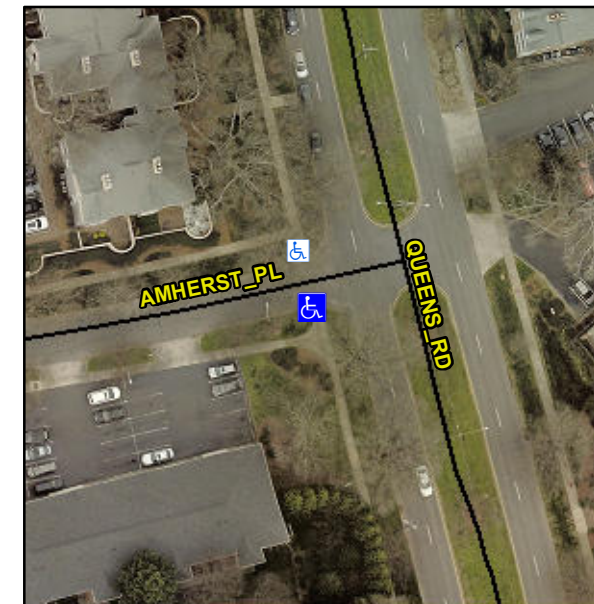
**R304.2.2, R304.5.3**

Compliance	Description	Data	Compliance	Description	Data
N/A	Ramp Length (in)	44.0	N/A	Grade Break?	N/A
Yes	Ramp Width (in)	48.0	N/A	Grade Break Slope (%)	0.0
No	Ramp Slope (%)	9.6	N/A	Grade Break XSlope (%)	0.0
No	Ramp XSlope (%)	12.2			
N/A	Flare Type LT	N/A	N/A	Flare Type RT	N/A
N/A	Flare Slope LT (%)	N/A	N/A	Flare Slope RT (%)	0.0
N/A	Flare Traversable LT?	N/A	N/A	Flare Traversable RT?	N/A
N/A	Landing Length (in)	0.0	N/A	DWS Provided?	N/A
N/A	Landing Width (in)	0.0	N/A	DWS Contrast?	N/A
N/A	Landing Slope (%)	0.0	N/A	DWS Length (in)	N/A
N/A	Landing X Slope (%)	0.0	N/A	DWS Full Width?	N/A
N/A	Landing Curb? (Y/N)	N/A	N/A	DWS Offset LT (in)	N/A
N/A	Shared Landing?	N/A	N/A	DWS Offset RT (in)	N/A
N/A	Gutter Ponding?	0.0	N/A	Gutter Slope (%)	N/A
N/A	Gutter Lip Ht (in)	0.0	N/A	Gutter X Slope (%)	N/A
N/A	Painted X Walk1?	No		Road Slope (%)	8.9
	X Walk 1 Direction	To NW		Road X Slope (%)	0.8
	X Walk 1 Width (in)	N/A		Clear Space?	N/A

**Remove & Replace Entire Ramp.**

\$ 1600.00

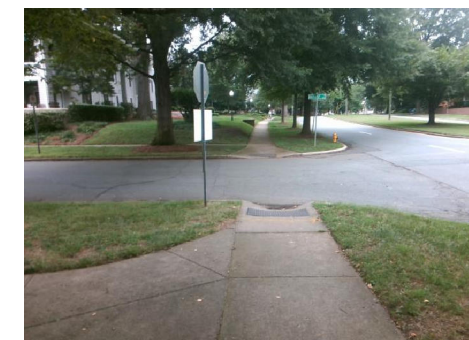
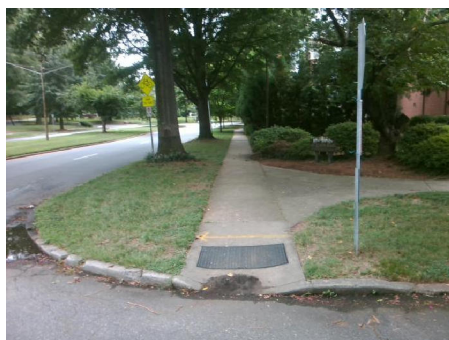
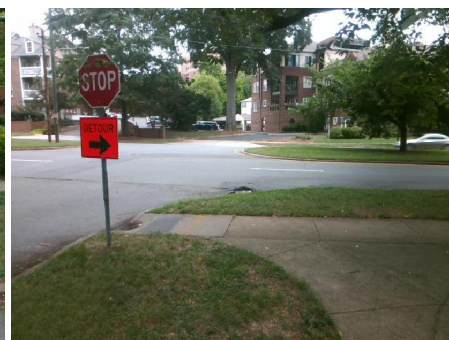
X Walk 1 Slope (%)	8.9	N/A	Clear Space to XWalk (in)	N/A
	X Walk 1 X Slope (%)	0.8	N/A	Storm Grate/Utility Hazard?	N/A
N/A	Ramp inside XWalk1?	N/A		Storm Grate/Utility Type	
N/A	Any Obstructions?	N/A			N/A
	Obstruction Type		Yes	Surface Condition? (G/P)	Good
			N/A	Curb Slope (%)	2.1
