Access Compliance Report Public Rights-of-Way (Curb Ramps)

Intersection ID: 16746 Main Street: PRINCETON_AV Cross Street: STERLING_RD Location: NE

ADA ID: E4A69BA697B2 Ramp Type: PerpDiag Initial Pass/Fail: Fail Overall Compliance: No Severity Score: 26.25

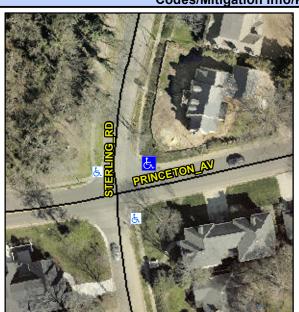
r leid Measurements/Component Compnance					
Compliance Description		Data	Compliance Description		Data
N/A	Ramp Length (in)	54.0	No	Ramp Slope (%)	15.6
Yes	Ramp Width (in)	79.0	No	Ramp XSlope (%)	2.8
N/A	Flare Type LT	N/A	N/A	Flare Type RT	N/A
N/A	Flare Slope LT (%)	N/A	N/A	Flare Slope RT (%)	N/A
N/A	Flare Traversable LT?	N/A	N/A	Flare Traversable RT?	N/A
N/A	Landing Length (in)	N/A	N/A	DWS Provided?	N/A
N/A	Landing Width (in)	N/A	N/A	DWS Contrast?	N/A
N/A	Landing Slope (%)	N/A	N/A	DWS Length (in)	N/A
N/A	Landing X Slope (%)	N/A	N/A	DWS Full Width?	N/A
N/A	Landing Curb? (Y/N)	N/A	N/A	DWS Offset (in)	N/A
N/A	Shared Landing?	N/A			
N/A	Gutter Ponding?	N/A	N/A	Gutter Slope (%)	N/A
N/A	Gutter Lip Ht (in)	N/A	N/A	Gutter X Slope (%)	N/A
N/A	Painted X Walk1?	No	N/A	Painted X Walk2?	No
	X Walk 1 Direction	To W		X Walk 2 Direction	To SW
N/A	X Walk 1 Width (in)	N/A	N/A	X Walk 2 Width (in)	N/A
	X Walk 1 Slope (%)	0.4		X Walk 2 Slope (%)	0.1

X Walk 1 X Slope (%)	4.1		X Walk 2 X Slope (%)	0.8
N/A	Ramp inside XWalk1?	N/A	N/A	Ramp inside XWalk2?	N/A
	Road Slope (%)	6.8	N/A	Clear Space?	N/A
	Road X Slope (%)	5.2	N/A	Clear Space to XWalk (in)	N/A
N/A	Any Obstructions?	N/A	N/A	Storm Grate/Utility Hazard?	N/A

Remove & Replace Curb Ramp With Two New Directional Ramps or Equivalent.

R304.2.2, R304.5.3

Total Cost: \$ 3200.00
