Access Compliance Report

Public Rights-of-Way

(Curb Ramps)

Intersection ID: 10030502	Main Street: LITTLE_AV	Cross Street: N/A	Location: NE
ADA ID: E4B9D5C428DA	Ramp Type: Directional1	Initial Pass/Fail: Fail	Overall Compliance: No
Severity Score: 37.5			
Codes/Mitigation Info/Possible Solution		Field Measurements/Component Compliance

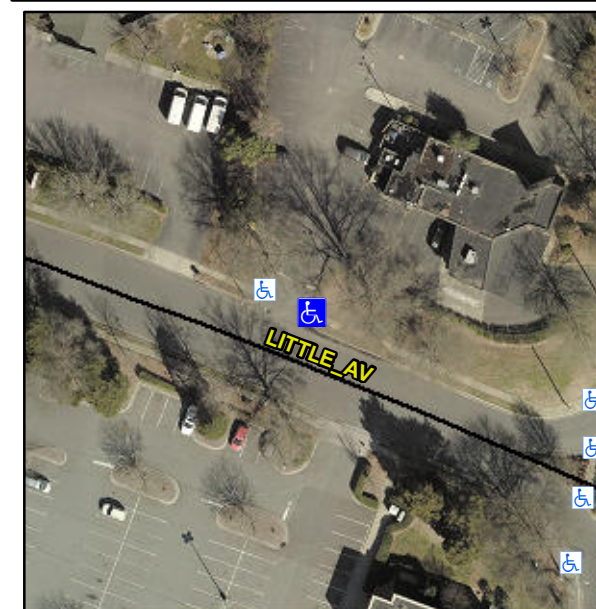
R304.2.2, R304.5.3

Compliance	Description	Data	Compliance	Description	Data
N/A	Ramp Length (in)	29.5	N/A	Grade Break?	N/A
Yes	Ramp Width (in)	48.0	N/A	Grade Break Slope (%)	0.0
No	Ramp Slope (%)	18.5	N/A	Grade Break XSlope (%)	0.0
No	Ramp XSlope (%)	5.3			
N/A	Flare Type LT	N/A	N/A	Flare Type RT	N/A
N/A	Flare Slope LT (%)	N/A	N/A	Flare Slope RT (%)	0.0
N/A	Flare Traversable LT?	N/A	N/A	Flare Traversable RT?	N/A
N/A	Landing Length (in)	0.0	N/A	DWS Provided?	N/A
N/A	Landing Width (in)	0.0	N/A	DWS Contrast?	N/A
N/A	Landing Slope (%)	0.0	N/A	DWS Length (in)	N/A
N/A	Landing X Slope (%)	0.0	N/A	DWS Full Width?	N/A
N/A	Landing Curb? (Y/N)	N/A	N/A	DWS Offset LT (in)	N/A
N/A	Shared Landing?	N/A	N/A	DWS Offset RT (in)	N/A
N/A	Gutter Ponding?	0.0	N/A	Gutter Slope (%)	N/A
N/A	Gutter Lip Ht (in)	0.0	N/A	Gutter X Slope (%)	N/A
N/A	Painted X Walk1?	No		Road Slope (%)	0.0
	X Walk 1 Direction	To W		Road X Slope (%)	1.3
	X Walk 1 Width (in)	N/A		Clear Space?	N/A

X Walk 1 Slope (%)	0.0	N/A	Clear Space to XWalk (in)	N/A
	X Walk 1 X Slope (%)	1.3	N/A	Storm Grate/Utility Hazard?	N/A
N/A	Ramp inside XWalk1?	N/A		Storm Grate/Utility Type	
N/A	Any Obstructions?	N/A			N/A
	Obstruction Type		Yes	Surface Condition? (G/P)	Good
			N/A	Curb Slope (%)	16.4

Remove & Replace Entire Ramp.
