# Access Compliance Report

## Public Rights-of-Way

### (Curb Ramps)

Intersection ID: 3276	Main Street: LAKE_SPRING_AV	Cross Street: W_W_T_HARRIS_BV	Location: SW
ADA ID: E4BE99BA04B8	Ramp Type: Perp	Initial Pass/Fail: Fail	Overall Compliance: No
			Severity Score: 10

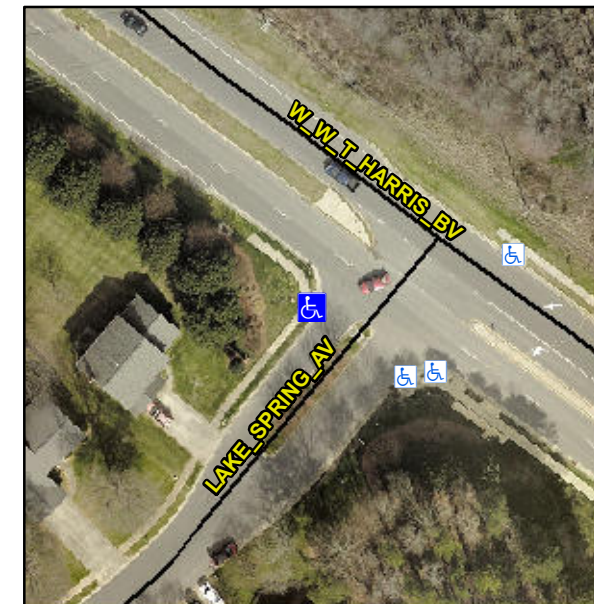
**R304.5.1, R304.5.3**

Compliance	Description	Data	Compliance	Description	Data
N/A	Ramp Length (in)	98.0	Yes	Ramp Slope (%)	7.3
No	Ramp Width (in)	46.5	No	Ramp XSlope (%)	4.1
N/A	Flare Type LT	N/A	N/A	Flare Type RT	N/A
N/A	Flare Slope LT (%)	N/A	N/A	Flare Slope RT (%)	N/A
N/A	Flare Traversable LT?	N/A	N/A	Flare Traversable RT?	N/A
N/A	Landing Length (in)	N/A	N/A	DWS Provided?	N/A
N/A	Landing Width (in)	N/A	N/A	DWS Contrast?	N/A
N/A	Landing Slope (%)	N/A	N/A	DWS Length (in)	N/A
N/A	Landing X Slope (%)	N/A	N/A	DWS Full Width?	N/A
N/A	Landing Curb? (Y/N)	N/A	N/A	DWS Offset (in)	N/A
N/A	Shared Landing?	N/A			
N/A	Gutter Ponding?	N/A	N/A	Gutter Slope (%)	N/A
N/A	Gutter Lip Ht (in)	N/A	N/A	Gutter X Slope (%)	N/A
N/A	Painted X Walk1?	No	N/A	Painted X Walk2?	N/A
	X Walk 1 Direction	To SE		X Walk 2 Direction	N/A
N/A	X Walk 1 Width (in)	N/A	N/A	X Walk 2 Width (in)	N/A
	X Walk 1 Slope (%)	1.4		X Walk 2 Slope (%)	N/A
	X Walk 1 X Slope (%)	1.3		X Walk 2 X Slope (%)	N/A

N/A	Ramp inside XWalk1?	N/A	N/A	Ramp inside XWalk2?	N/A
	Road Slope (%)	N/A	N/A	Clear Space?	N/A
	Road X Slope (%)	N/A	N/A	Clear Space to XWalk (in)	N/A
N/A	Any Obstructions?	N/A	N/A	Storm Grate/Utility Hazard?	N/A
	Obstruction Type			Storm Grate/Utility Type	
		N/A			N/A
			Yes	Surface Condition? (G/P)	Good

**Remove & Replace Entire Ramp.**

Total Cost: \$ 1850.00
