# Access Compliance Report

## Public Rights-of-Way

### (Curb Ramps)

Intersection ID: 12611	Main Street: S_CHURCH_ST	Cross Street: W_STONEWALL_ST	Location: N
ADA ID: E4C1581F6C9F	Ramp Type: PerpDiag	Initial Pass/Fail: Pass	Overall Compliance: No
Severity Score: 22.75			
Codes/Mitigation Info/Possible Solution		Field Measurements/Component Compliance

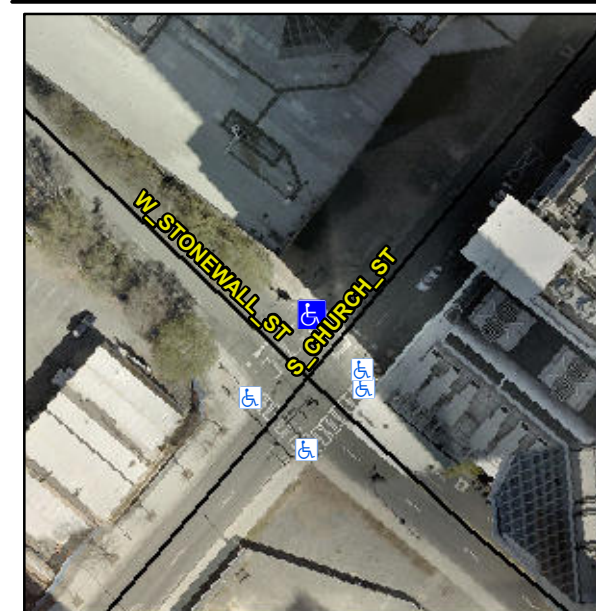
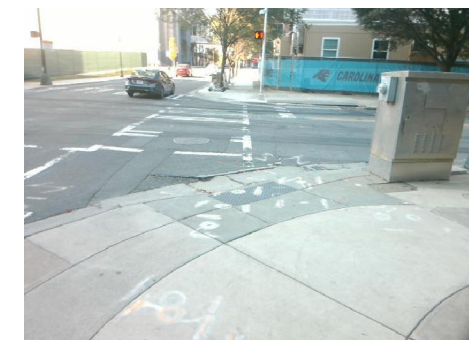
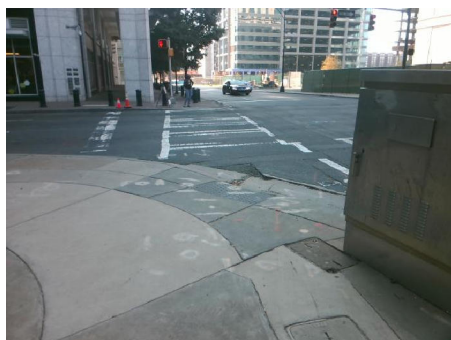
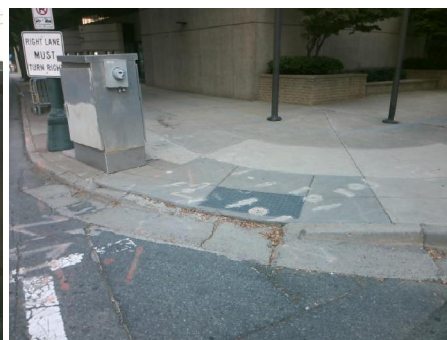
**Not Found, R304.5.3, R304.2.3, R305.2, R302.7.2, R304.5.4**

Compliance	Description	Data	Compliance	Description	Data
N/A	Ramp Length (in)	60.0	Yes	Ramp Slope (%)	6.3
Yes	Ramp Width (in)	48.0	No	Ramp XSlope (%)	3.9
N/A	Flare Type LT	Sloped	N/A	Flare Type RT	N/A
N/A	Flare Slope LT (%)	6.4	No	Flare Slope RT (%)	12.0
N/A	Flare Traversable LT?	No	N/A	Flare Traversable RT?	Yes
Yes	Landing Length (in)	60.0	Yes	DWS Provided?	Yes
Yes	Landing Width (in)	60.0	Yes	DWS Contrast?	Yes
Yes	Landing Slope (%)	0.3	Yes	DWS Length (in)	24.0
Yes	Landing X Slope (%)	0.7	Yes	DWS Full Width?	Yes
N/A	Landing Curb? (Y/N)	No	No	DWS Offset (in)	4.5
N/A	Shared Landing?	No			
Yes	Gutter Ponding?	No	No	Gutter Slope (%)	5.7
No	Gutter Lip Ht (in)	4.0	Yes	Gutter X Slope (%)	1.9
N/A	Painted X Walk1?	Yes	N/A	Painted X Walk2?	Yes
	X Walk 1 Direction	To SW		X Walk 2 Direction	To SE
N/A	X Walk 1 Width (in)	118.0	N/A	X Walk 2 Width (in)	111.0
	X Walk 1 Slope (%)	1.6		X Walk 2 Slope (%)	5.3
	X Walk 1 X Slope (%)	2.5		X Walk 2 X Slope (%)	2.1

Yes	Ramp inside XWalk1?	Yes	Yes	Ramp inside XWalk2?	Yes
	Road Slope (%)	0.2	N/A	Clear Space?	Yes
	Road X Slope (%)	4.8	Yes	Clear Space to XWalk (in)	90.0
Yes	Any Obstructions?	No	Yes	Storm Grate/Utility Hazard?	No
	Obstruction Type			Storm Grate/Utility Type	
		N/A			N/A
			Yes	Surface Condition? (G/P)	Good

**Remove & Replace Curb Ramp With Two New Directional Ramps or Equivalent. Remove & Replace Gutter.**
