Access Compliance Report

Public Rights-of-Way

(Curb Ramps)

Intersection ID: 15125	Main Street: CHEROKEE_RD	Cross Street: PROVIDENCE_RD	Location: SE
ADA ID: E4C2C8E200ED	Ramp Type: PerpDiag	Initial Pass/Fail: Fail	Overall Compliance: No
		Severity Score: 22.5

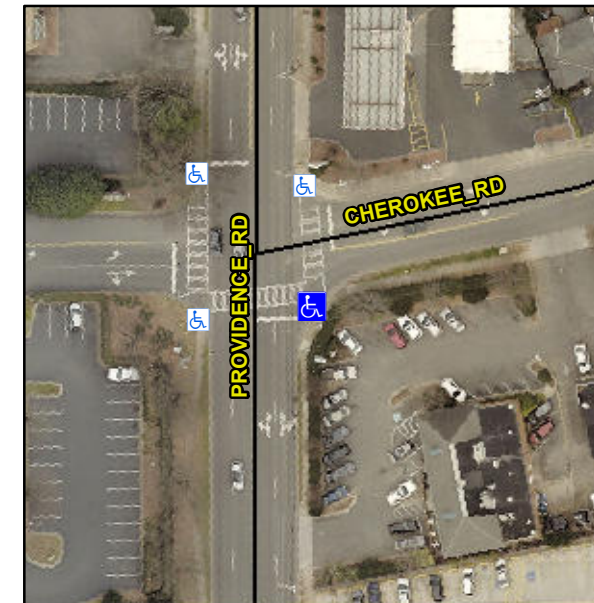
R304.5.1, R304.2.2

Compliance	Description	Data	Compliance	Description	Data
N/A	Ramp Length (in)	59.0	No	Ramp Slope (%)	8.6
No	Ramp Width (in)	46.0	Yes	Ramp XSlope (%)	4.0
N/A	Flare Type LT	N/A	N/A	Flare Type RT	N/A
N/A	Flare Slope LT (%)	N/A	N/A	Flare Slope RT (%)	N/A
N/A	Flare Traversable LT?	N/A	N/A	Flare Traversable RT?	N/A
N/A	Landing Length (in)	N/A	N/A	DWS Provided?	N/A
N/A	Landing Width (in)	N/A	N/A	DWS Contrast?	N/A
N/A	Landing Slope (%)	N/A	N/A	DWS Length (in)	N/A
N/A	Landing X Slope (%)	N/A	N/A	DWS Full Width?	N/A
N/A	Landing Curb? (Y/N)	N/A	N/A	DWS Offset (in)	N/A
N/A	Shared Landing?	N/A			
N/A	Gutter Ponding?	N/A	N/A	Gutter Slope (%)	N/A
N/A	Gutter Lip Ht (in)	N/A	N/A	Gutter X Slope (%)	N/A
N/A	Painted X Walk1?	Yes	N/A	Painted X Walk2?	Yes
	X Walk 1 Direction	To N		X Walk 2 Direction	To W
N/A	X Walk 1 Width (in)	108.0	N/A	X Walk 2 Width (in)	111.0
	X Walk 1 Slope (%)	2.2		X Walk 2 Slope (%)	6.3
	X Walk 1 X Slope (%)	5.8		X Walk 2 X Slope (%)	1.3

N/A	Ramp inside XWalk1?	Yes	N/A	Ramp inside XWalk2?	No
	Road Slope (%)	4.4	N/A	Clear Space?	N/A
	Road X Slope (%)	5.9	N/A	Clear Space to XWalk (in)	N/A
N/A	Any Obstructions?	N/A	N/A	Storm Grate/Utility Hazard?	N/A
	Obstruction Type			Storm Grate/Utility Type	
		N/A			N/A
		Yes		Surface Condition? (G/P)	Good

Remove & Replace Curb Ramp With Two New Directional Ramps or Equivalent. Restripe Crosswalk.
