Access Compliance Report

Public Rights-of-Way

(Curb Ramps)

Intersection ID: 3509	Main Street: COPENHAGEN_LN	Cross Street: MT_HOLLY-HUNTERSVILLE_RD	Location: SE
ADA ID: E4C5AD7AEEA1	Ramp Type: Perp	Initial Pass/Fail: Fail	Overall Compliance: No
Severity Score: 12.5			
Codes/Mitigation Info/Possible Solution		Field Measurements/Component Compliance

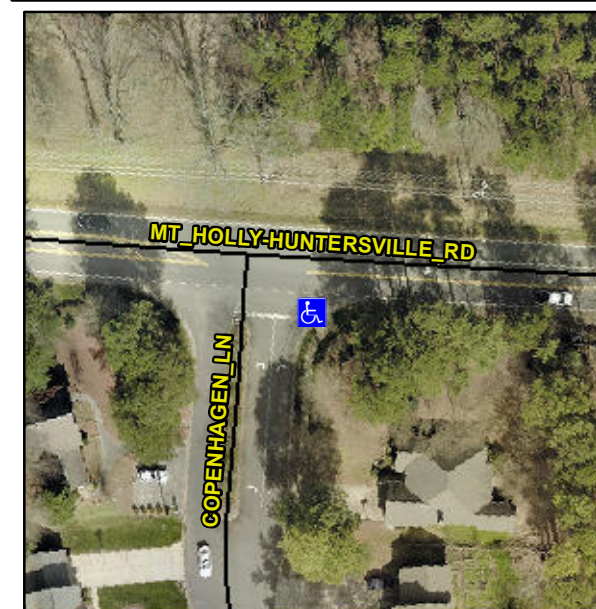
Compliance	Description	Data	Compliance	Description	Data
N/A	Ramp Length (in)	96.0	No	Ramp Slope (%)	11.2
Yes	Ramp Width (in)	78.0	Yes	Ramp XSlope (%)	1.3
N/A	Flare Type LT	N/A	N/A	Flare Type RT	N/A
N/A	Flare Slope LT (%)	N/A	N/A	Flare Slope RT (%)	N/A
N/A	Flare Traversable LT?	N/A	N/A	Flare Traversable RT?	N/A
N/A	Landing Length (in)	N/A	N/A	DWS Provided?	N/A
N/A	Landing Width (in)	N/A	N/A	DWS Contrast?	N/A
N/A	Landing Slope (%)	N/A	N/A	DWS Length (in)	N/A
N/A	Landing X Slope (%)	N/A	N/A	DWS Full Width?	N/A
N/A	Landing Curb? (Y/N)	N/A	N/A	DWS Offset (in)	N/A
N/A	Shared Landing?	N/A			
N/A	Gutter Ponding?	N/A	N/A	Gutter Slope (%)	N/A
N/A	Gutter Lip Ht (in)	N/A	N/A	Gutter X Slope (%)	N/A
N/A	Painted X Walk1?	No	N/A	Painted X Walk2?	N/A
	X Walk 1 Direction	To W		X Walk 2 Direction	N/A
N/A	X Walk 1 Width (in)	N/A	N/A	X Walk 2 Width (in)	N/A
	X Walk 1 Slope (%)	0.8		X Walk 2 Slope (%)	N/A
	X Walk 1 X Slope (%)	0.7		X Walk 2 X Slope (%)	N/A

N/A	Ramp inside XWalk1?	N/A	N/A	Ramp inside XWalk2?	N/A
	Road Slope (%)	0.7	N/A	Clear Space?	N/A
	Road X Slope (%)	0.8	N/A	Clear Space to XWalk (in)	N/A
N/A	Any Obstructions?	N/A	N/A	Storm Grate/Utility Hazard?	N/A
	Obstruction Type			Storm Grate/Utility Type	
		N/A			N/A
			Yes	Surface Condition? (G/P)	Good

Possible Solutions:

Remove & Replace Entire Ramp.

R304.2.2

Total Cost: \$ 1850.00
