# Access Compliance Report

## Public Rights-of-Way

### (Curb Ramps)

Intersection ID: 10037292	Main Street: SARDIS_RD	Cross Street: N/A	Location: NW
ADA ID: E4C5CC44B1C1	Ramp Type: MedianPerp	Initial Pass/Fail: Fail	Overall Compliance: No
Severity Score: 58.75			
Codes/Mitigation Info/Possible Solution		Field Measurements/Component Compliance

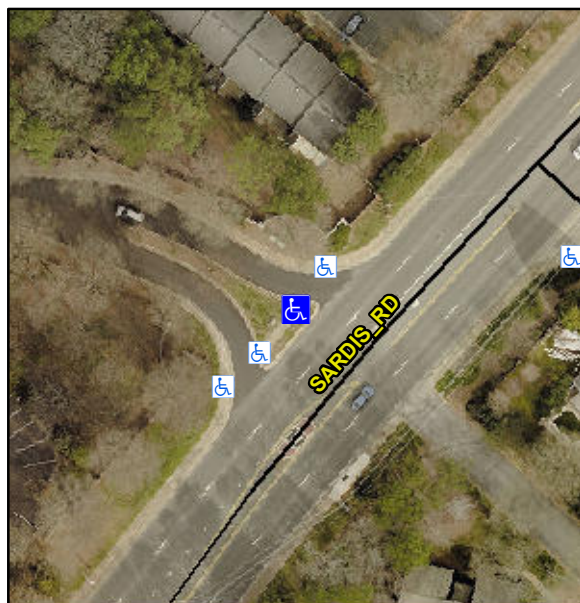
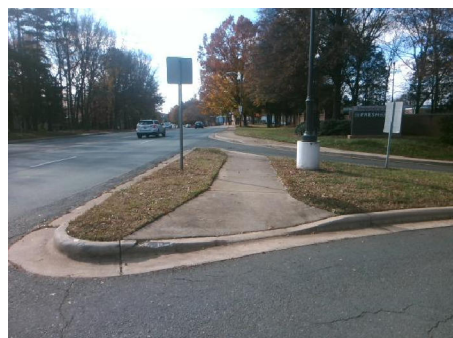
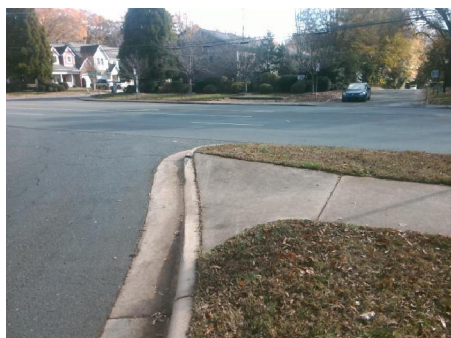
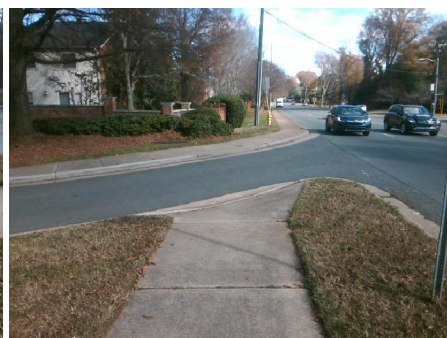
**Not Found, R304.5.1, R304.2.2, R304.5.3**

Compliance	Description	Data	Compliance	Description	Data
N/A	Ramp Length (in)	68.0	No	Ramp Slope (%)	17.3
No	Ramp Width (in)	46.0	No	Ramp XSlope (%)	9.0
N/A	Flare Type LT	N/A	N/A	Flare Type RT	N/A
N/A	Flare Slope LT (%)	N/A	N/A	Flare Slope RT (%)	N/A
N/A	Flare Traversable LT?	N/A	N/A	Flare Traversable RT?	N/A
N/A	Landing Length (in)	N/A	N/A	DWS Provided?	N/A
N/A	Landing Width (in)	N/A	N/A	DWS Contrast?	N/A
N/A	Landing Slope (%)	N/A	N/A	DWS Length (in)	N/A
N/A	Landing X Slope (%)	N/A	N/A	DWS Full Width?	N/A
N/A	Landing Curb? (Y/N)	N/A	N/A	DWS Offset (in)	N/A
N/A	Shared Landing?	N/A			
N/A	Gutter Ponding?	N/A	N/A	Gutter Slope (%)	N/A
N/A	Gutter Lip Ht (in)	N/A	N/A	Gutter X Slope (%)	N/A
N/A	Painted X Walk1?	No	N/A	Painted X Walk2?	N/A
	X Walk 1 Direction	To NE		X Walk 2 Direction	N/A
N/A	X Walk 1 Width (in)	N/A	N/A	X Walk 2 Width (in)	N/A
	X Walk 1 Slope (%)	2.7		X Walk 2 Slope (%)	N/A
	X Walk 1 X Slope (%)	7.6		X Walk 2 X Slope (%)	N/A

N/A	Ramp inside XWalk1?	N/A	N/A	Ramp inside XWalk2?	N/A
	Road Slope (%)	N/A	N/A	Clear Space?	N/A
	Road X Slope (%)	N/A	N/A	Clear Space to XWalk (in)	N/A
N/A	Any Obstructions?	N/A	N/A	Storm Grate/Utility Hazard?	N/A
	Obstruction Type			Storm Grate/Utility Type	
		N/A			N/A
			Yes	Surface Condition? (G/P)	Good

Possible Solutions:

**Remove & Replace Entire Ramp.**
