## Access Compliance Report Public Rights-of-Way (Curb Ramps)

Intersection ID: 52081	081 Main Street: LAWYERS_RD			Cross Street: E_W_T_HARRIS_BV				Location:	SE
ADA ID: E4C806A56F40 Ramp Type: Perp			Initial I	Initial Pass/Fail: Fail Overall Compliance: No				o Severity Score:	13.75
Codes/Mitigation Info/Possible Solution				Field Measurements/Component Compliance					
		Possible Solutions:		Compliance Description			Data Compliance Description		Data
		Remove & Replace Entire Ram	0.	N/A	Ramp Length (in)	94.5	No	Ramp Slope (%)	8.9
				Yes	Ramp Width (in)	48.0	No	Ramp XSlope (%)	2.1
	S CALLER LINE			N/A	Flare Type LT	N/A	N/A	Flare Type RT	N/A
5 b				N/A	Flare Slope LT (%)	N/A	N/A	Flare Slope RT (%)	N/A
5 m H				N/A	Flare Traversable LT?	N/A	N/A	Flare Traversable RT?	N/A
E LAWAR	1 Mar			N/A	Landing Length (in)	N/A	N/A	DWS Provided?	N/A
	the second second	Surveyor Notes:		N/A	Landing Width (in)	N/A	N/A	DWS Contrast?	N/A
E t		N/A		N/A	Landing Slope (%)	N/A	N/A	DWS Length (in)	N/A

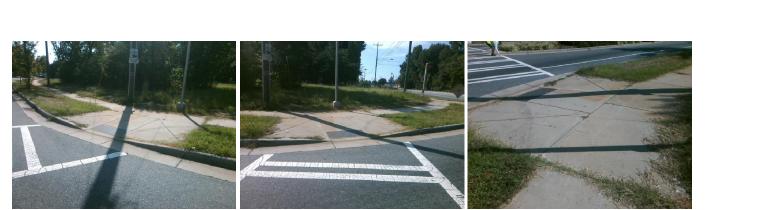
BE S.			N/A	Landing X Slope (%)	N/A	N/A	DWS Full Width?	N/A
Enter State				N/A	Landing Curb? (Y/N)	N/A	N/A	DWS Offset (in)	N/A
6.ILT SILO	No.			N/A	Shared Landing?	N/A			
	12 16 10 10	PROW/ADA:		N/A	Gutter Ponding?	N/A	N/A	Gutter Slope (%)	N/A
JR. DI		Not Found, R304.2.2, R304.5.3		N/A	Gutter Lip Ht (in)	N/A	N/A	Gutter X Slope (%)	N/A
	1 1 1 1 1 1 1 1 1 1 1 1 1 1 1 1 1 1 1			N/A	Painted X Walk1?	Yes	N/A	Painted X Walk2?	N/A
A P R SHOLE					X Walk 1 Direction	To N		X Walk 2 Direction	N/A
				N/A	X Walk 1 Width (in)	122.0	N/A	X Walk 2 Width (in)	N/A
Street 1 Name	LAWYERS RD				X Walk 1 Slope (%)	1.4		X Walk 2 Slope (%)	N/A
Stop Condition-Street 2	Signal				X Walk 1 X Slope (%)	1.8		X Walk 2 X Slope (%)	N/A
Street 2 Name	N/A			N/A	Ramp inside XWalk1?	Yes	N/A	Ramp inside XWalk2?	N/A
Stop Condition-Street 1	N/A				Road Slope (%)	N/A	N/A	Clear Space?	N/A
					Road X Slope (%)	N/A	N/A	Clear Space to XWalk (in)	N/A

N/A	Any Obstructions?	N/A	N/A	Storm Grate/Utility Hazard?	N/A
		Total Cost: \$	1850.00		Obstruction Type			Storm Grate/Utility Type	
						N/A			N/A
