Access Compliance Report

Public Rights-of-Way

(Curb Ramps)

Intersection ID: 7615	Main Street: ECHO_GLEN_RD	Cross Street: VALEN_WY	Location: NE
ADA ID: E4D45AB61E35	Ramp Type: Directional1	Initial Pass/Fail: Fail	Overall Compliance: No
Codes/Mitigation Info/Possible Solution		Severity Score: 8.75	
		Field Measurements/Component Compliance

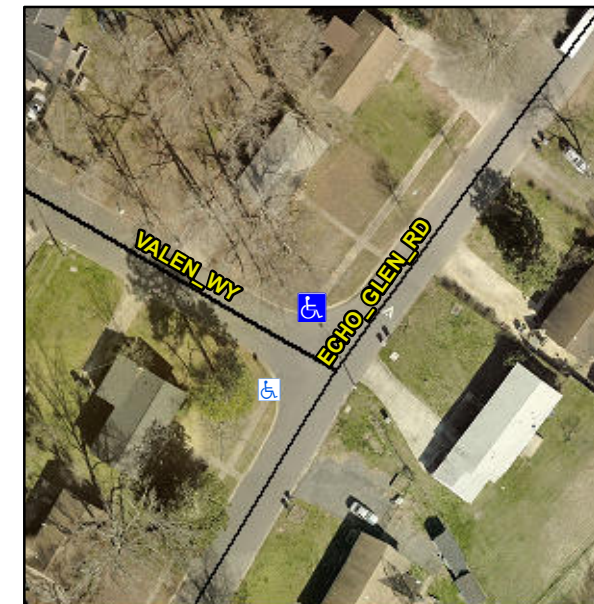
R304.5.1

Compliance	Description	Data	Compliance	Description	Data
N/A	Ramp Length (in)	74.0	N/A	Grade Break?	N/A
No	Ramp Width (in)	44.0	N/A	Grade Break Slope (%)	0.0
Yes	Ramp Slope (%)	5.3	N/A	Grade Break XSlope (%)	0.0
Yes	Ramp XSlope (%)	0.3			
N/A	Flare Type LT	N/A	N/A	Flare Type RT	N/A
N/A	Flare Slope LT (%)	N/A	N/A	Flare Slope RT (%)	0.0
N/A	Flare Traversable LT?	N/A	N/A	Flare Traversable RT?	N/A
N/A	Landing Length (in)	0.0	N/A	DWS Provided?	N/A
N/A	Landing Width (in)	0.0	N/A	DWS Contrast?	N/A
N/A	Landing Slope (%)	0.0	N/A	DWS Length (in)	N/A
N/A	Landing X Slope (%)	0.0	N/A	DWS Full Width?	N/A
N/A	Landing Curb? (Y/N)	N/A	N/A	DWS Offset LT (in)	N/A
N/A	Shared Landing?	N/A	N/A	DWS Offset RT (in)	N/A
N/A	Gutter Ponding?	0.0	N/A	Gutter Slope (%)	N/A
N/A	Gutter Lip Ht (in)	0.5	N/A	Gutter X Slope (%)	N/A
N/A	Painted X Walk1?	No		Road Slope (%)	3.2
	X Walk 1 Direction	To SW		Road X Slope (%)	1.4
	X Walk 1 Width (in)	N/A		Clear Space?	N/A

X Walk 1 Slope (%)	3.2	N/A	Clear Space to XWalk (in)	N/A
	X Walk 1 X Slope (%)	1.4	N/A	Storm Grate/Utility Hazard?	N/A
N/A	Ramp inside XWalk1?	N/A		Storm Grate/Utility Type	
N/A	Any Obstructions?	N/A			N/A
	Obstruction Type		Yes	Surface Condition? (G/P)	Good
			N/A	Curb Slope (%)	23.2

Possible Solutions:

Remove & Replace Entire Ramp.
