# Access Compliance Report

## Public Rights-of-Way

| Intersection ID: 28729 | Main Street: AVENTIDE_LN | Cross Street: STEWARTS_CROSSING_DR | Location: NW |
| ADA ID: E4D92FC371B4 | Ramp Type: BlendTrans1 | Initial Pass/Fail: Fail | Overall Compliance: No |

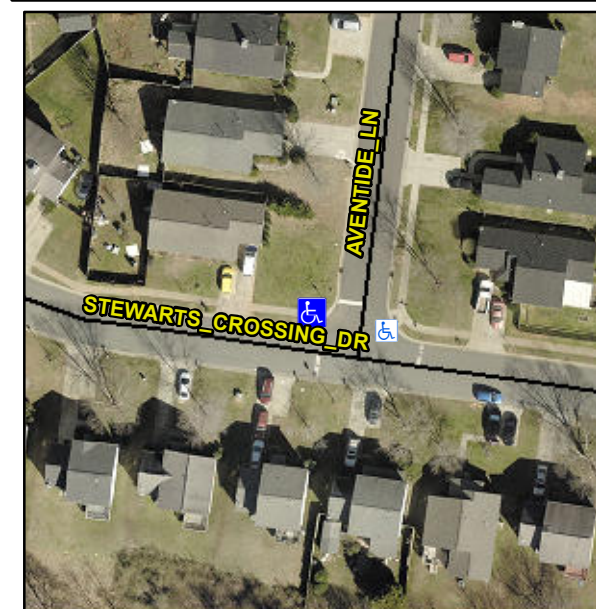
**NO RT SW**

**Not Found, R304.5.1, R304.5.3**

| Compliance | Description | Data | Compliance | Description | Data |
|---|---|---|---|---|---|
| No | Ramp Width (in) | 37.0 | No | BlendTrans XSlope (%) | 3.3 |

**Remove & Replace Curb Ramp With Two New Directional Ramps or Equivalent.**
