# Access Compliance Report

## Public Rights-of-Way

### (Curb Ramps)

Intersection ID: 26289	Main Street: BEVINGTON_PL	Cross Street: FISHER'S_POND_DR	Location: NW
ADA ID: E4DDBFC95F98	Ramp Type: PerpDiag	Initial Pass/Fail: Fail	Overall Compliance: No
			Severity Score: 21.25

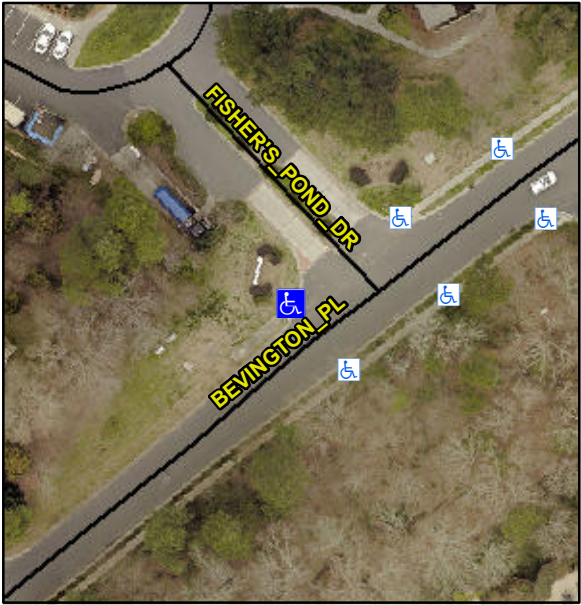
Possible Solutions:		<b>Compliance</b>	<b>Description</b>	<b>Data</b>
	<b>Remove &amp; Replace Curb Ramp With Two New Directional Ramps or Equivalent.</b>		<b>Yes</b>	Ramp Length (in)	7.9
			<b>No</b>	Ramp Width (in)	5.7
			<b>N/A</b>	Flare Type LT	N/A
			<b>N/A</b>	Flare Slope LT (%)	N/A
			<b>N/A</b>	Flare Traversable LT?	N/A
			<b>N/A</b>	Landing Length (in)	N/A
			<b>N/A</b>	Landing Width (in)	N/A
			<b>N/A</b>	Landing Slope (%)	N/A
			<b>N/A</b>	Landing X Slope (%)	N/A
<p>Surveyor Notes:</p> <p><b>N/A</b></p> <p>PROW/ADA:</p> <p><b>R304.5.1, R304.5.3</b></p>			<b>N/A</b>	Flare Type RT	N/A
			<b>N/A</b>	Flare Slope RT (%)	N/A
			<b>N/A</b>	Flare Traversable RT?	N/A
			<b>N/A</b>	DWS Provided?	N/A
			<b>N/A</b>	DWS Contrast?	N/A
			<b>N/A</b>	DWS Length (in)	N/A
			<b>N/A</b>	DWS Full Width?	N/A
			<b>N/A</b>	DWS Offset (in)	N/A

<b>N/A</b>	Shared Landing?	N/A
			<b>N/A</b>	Gutter Ponding?	N/A
			<b>N/A</b>	Gutter Lip Ht (in)	N/A
			<b>No</b>	Painted X Walk1?	No
				X Walk 1 Direction	To SE
			<b>N/A</b>	X Walk 1 Width (in)	N/A
			<b>4.9</b>	X Walk 1 Slope (%)	2.9
			<b>4.5</b>	X Walk 1 X Slope (%)	1.8
			<b>N/A</b>	Ramp inside XWalk1?	N/A
			<b>5.1</b>	Road Slope (%)	N/A
			<b>2.7</b>	Road X Slope (%)	N/A
			<b>N/A</b>	Any Obstructions?	N/A
			<b>N/A</b>	Obstruction Type	N/A
			<b>N/A</b>		N/A
			<b>Yes</b>	Surface Condition? (G/P)	Good
