Access Compliance Report

Public Rights-of-Way

(Curb Ramps)

Intersection ID: 9810	Main Street: BRIDGEPORT_DR	Cross Street: THE_PLAZA	Location: SW
ADA ID: E4E0C63A48A4	Ramp Type: Perp	Initial Pass/Fail: Pass	Overall Compliance: No
			Severity Score: 22.75

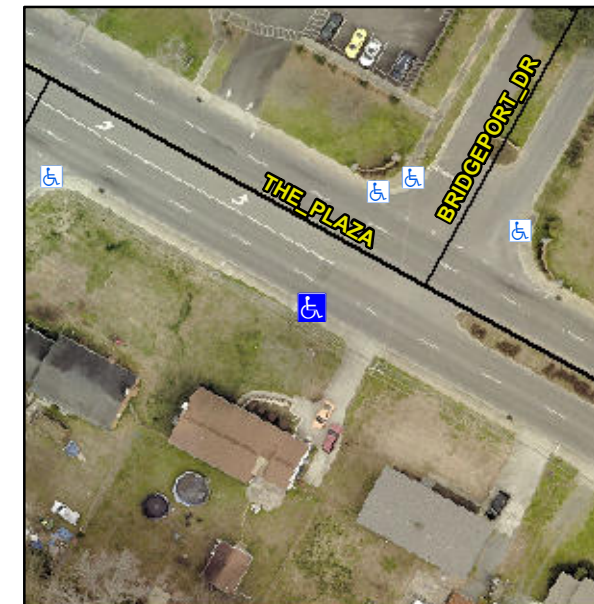
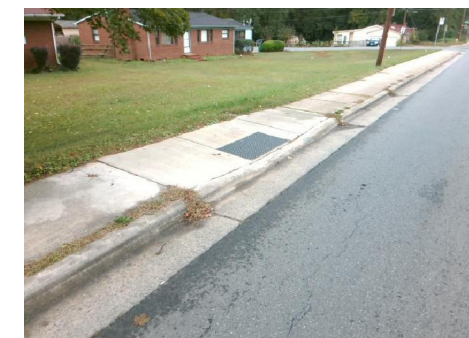
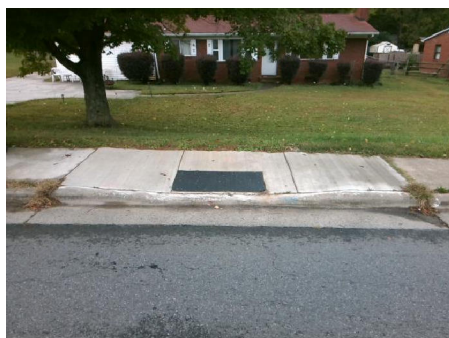
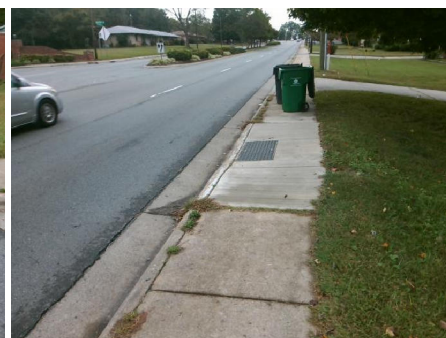
**Not Found, R304.5.3, R304.2.1,
R304.2.2-Perp, R304.3.2-Para,
R302.7, R302.7.2, R304.5.4**

Compliance	Description	Data	Compliance	Description	Data
N/A	Ramp Length (in)	59.5	Yes	Ramp Slope (%)	7.0
Yes	Ramp Width (in)	48.0	No	Ramp XSlope (%)	3.0
N/A	Flare Type LT	Sloped	N/A	Flare Type RT	N/A
N/A	Flare Slope LT (%)	7.5	Yes	Flare Slope RT (%)	4.8
N/A	Flare Traversable LT?	Yes	N/A	Flare Traversable RT?	Yes
No	Landing Length (in)	N/A	Yes	DWS Provided?	Yes
No	Landing Width (in)	N/A	Yes	DWS Contrast?	Yes
No	Landing Slope (%)	N/A	Yes	DWS Length (in)	24.0
No	Landing X Slope (%)	N/A	Yes	DWS Full Width?	Yes
N/A	Landing Curb? (Y/N)	No	Yes	DWS Offset (in)	2.0
N/A	Shared Landing?	No			
No	Gutter Ponding?	Yes	No	Gutter Slope (%)	5.8
No	Gutter Lip Ht (in)	0.5	No	Gutter X Slope (%)	2.3
N/A	Painted X Walk1?	No	N/A	Painted X Walk2?	N/A
	X Walk 1 Direction	To NE		X Walk 2 Direction	N/A
N/A	X Walk 1 Width (in)	N/A	N/A	X Walk 2 Width (in)	N/A
	X Walk 1 Slope (%)	2.3		X Walk 2 Slope (%)	N/A
	X Walk 1 X Slope (%)	2.0		X Walk 2 X Slope (%)	N/A

N/A	Ramp inside XWalk1?	N/A	N/A	Ramp inside XWalk2?	N/A
	Road Slope (%)	N/A	N/A	Clear Space?	Yes
	Road X Slope (%)	N/A	N/A	Clear Space to XWalk (in)	N/A
Yes	Any Obstructions?	No	Yes	Storm Grate/Utility Hazard?	No
	Obstruction Type			Storm Grate/Utility Type	
		N/A			N/A
			Yes	Surface Condition? (G/P)	Good

**Remove & Replace Entire Ramp.
Remove & Replace Gutter.**
