Access Compliance Report

Public Rights-of-Way

(Curb Ramps)

Intersection ID: 46314	Main Street: TORTOLA_RD	Cross Street: MOSS_LAKE_RD	Location: W
ADA ID: E4E0D78A187B	Ramp Type: BlendTrans1	Initial Pass/Fail: Fail	Overall Compliance: No
Severity Score: 10			
Codes/Mitigation Info/Possible Solution		Field Measurements/Component Compliance

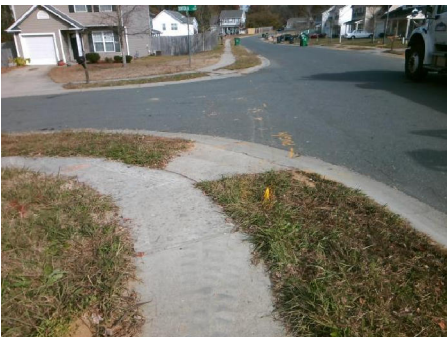
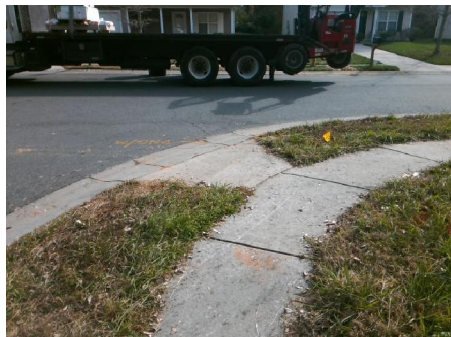
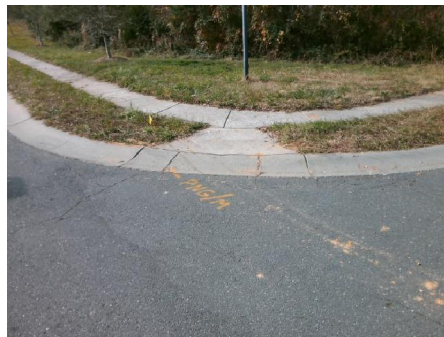
CURB GAP 1.0

Not Found, R304.5.1

Compliance	Description	Data	Compliance	Description	Data
N/A	Ramp Length (in)	47.0	Yes	BlendTrans Slope (%)	2.1
No	Ramp Width (in)	44.5	Yes	BlendTrans XSlope (%)	2.2
N/A	Flare Type LT	N/A	N/A	Flare Type RT	N/A
N/A	Flare Slope LT (%)	N/A	N/A	Flare Slope RT (%)	N/A
N/A	Flare Traversable LT?	N/A	N/A	Flare Traversable RT?	N/A
N/A	Landing Length (in)	N/A	N/A	DWS Provided?	N/A
N/A	Landing Width (in)	N/A	N/A	DWS Contrast?	N/A
N/A	Landing Slope (%)	N/A	N/A	DWS Length (in)	N/A
N/A	Landing X Slope (%)	N/A	N/A	DWS Full Width?	N/A
N/A	Landing Curb? (Y/N)	N/A	N/A	DWS Offset (in)	N/A
N/A	Shared Landing?	N/A			
N/A	Gutter Ponding?	N/A	N/A	Gutter Slope (%)	N/A
N/A	Gutter Lip Ht (in)	N/A	N/A	Gutter X Slope (%)	N/A
N/A	Painted X Walk1?	No	N/A	Painted X Walk2?	No
	X Walk 1 Direction	To SE		X Walk 2 Direction	To NE
	X Walk 1 Width (in)	N/A		X Walk 2 Width (in)	N/A
	X Walk 1 Slope (%)	4.7		X Walk 2 Slope (%)	2.3
	X Walk 1 X Slope (%)	1.2		X Walk 2 X Slope (%)	4.5

N/A	Ramp inside XWalk1?	N/A	N/A	Ramp inside XWalk2?	N/A
	Road Slope (%)	2.7		Clear Space?	N/A
	Road X Slope (%)	3.7	N/A	Clear Space to XWalk (in)	N/A
N/A	Any Obstructions?	N/A	N/A	Storm Grate/Utility Hazard?	N/A
	Obstruction Type			Storm Grate/Utility Type	
		N/A			N/A
			Yes	Surface Condition? (G/P)	Good
			No	Curb Slope (%)	12.9

Possible Solutions:

Remove & Replace Curb Ramp With Two New Directional Ramps or Equivalent.
