# Access Compliance Report

## Public Rights-of-Way

### (Curb Ramps)

Intersection ID: 9982	Main Street: E_36TH_ST	Cross Street: N_DAVIDSON_ST	Location: N
ADA ID: E4EEB7613F88	Ramp Type: PerpDiag	Initial Pass/Fail: Fail	Overall Compliance: No
Severity Score: 26.25			
Codes/Mitigation Info/Possible Solution		Field Measurements/Component Compliance

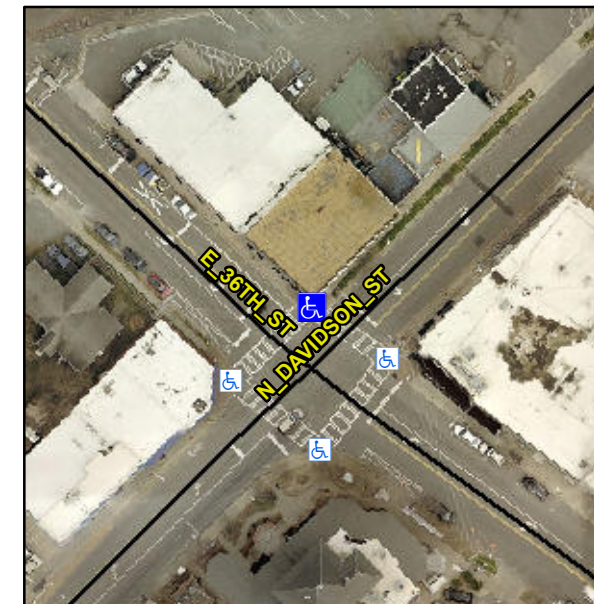
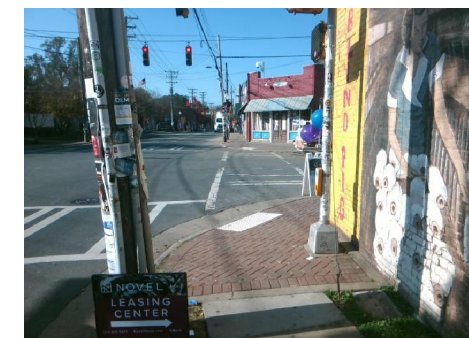
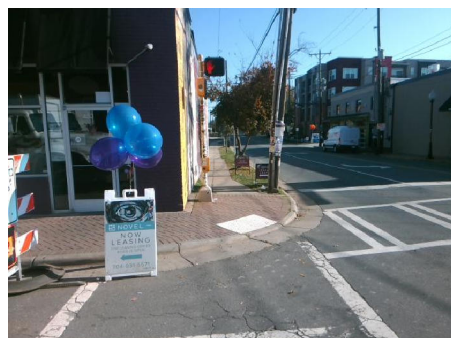
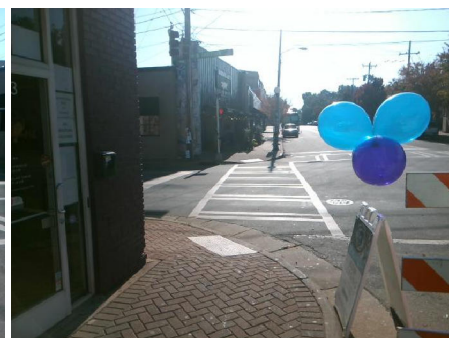
Compliance	Description	Data	Compliance	Description	Data
N/A	Ramp Length (in)	60.0	No	Ramp Slope (%)	13.7
Yes	Ramp Width (in)	48.0	No	Ramp XSlope (%)	4.1
N/A	Flare Type LT	N/A	N/A	Flare Type RT	N/A
N/A	Flare Slope LT (%)	N/A	N/A	Flare Slope RT (%)	N/A
N/A	Flare Traversable LT?	N/A	N/A	Flare Traversable RT?	N/A
N/A	Landing Length (in)	N/A	N/A	DWS Provided?	N/A
N/A	Landing Width (in)	N/A	N/A	DWS Contrast?	N/A
N/A	Landing Slope (%)	N/A	N/A	DWS Length (in)	N/A
N/A	Landing X Slope (%)	N/A	N/A	DWS Full Width?	N/A
N/A	Landing Curb? (Y/N)	N/A	N/A	DWS Offset (in)	N/A
N/A	Shared Landing?	N/A			
N/A	Gutter Ponding?	N/A	N/A	Gutter Slope (%)	N/A
N/A	Gutter Lip Ht (in)	2.0	N/A	Gutter X Slope (%)	N/A
N/A	Painted X Walk1?	Yes	N/A	Painted X Walk2?	Yes
	X Walk 1 Direction	To SW		X Walk 2 Direction	To SE
N/A	X Walk 1 Width (in)	110.0	N/A	X Walk 2 Width (in)	108.0
	X Walk 1 Slope (%)	2.5		X Walk 2 Slope (%)	2.3
	X Walk 1 X Slope (%)	0.2		X Walk 2 X Slope (%)	4.4

N/A	Ramp inside XWalk1?	Yes	N/A	Ramp inside XWalk2?	Yes
	Road Slope (%)	2.3	N/A	Clear Space?	N/A
	Road X Slope (%)	3.8	N/A	Clear Space to XWalk (in)	N/A
N/A	Any Obstructions?	N/A	N/A	Storm Grate/Utility Hazard?	N/A
	Obstruction Type			Storm Grate/Utility Type	
		N/A			N/A
		Yes		Surface Condition? (G/P)	Good

Possible Solutions:

**Remove & Replace Curb Ramp With Two New Directional Ramps or Equivalent.**

PROW/ADA:

**R304.2.2, R304.5.3**
