# Access Compliance Report

## Public Rights-of-Way

### (Curb Ramps)

Intersection ID: 42944	Main Street: TURNING_WHEEL_DR	Cross Street: SONOMA_VALLEY_DR	Location: SW
ADA ID: E4F14B91B168	Ramp Type: PerpDiag	Initial Pass/Fail: Fail	Overall Compliance: No
		Severity Score: 8.75

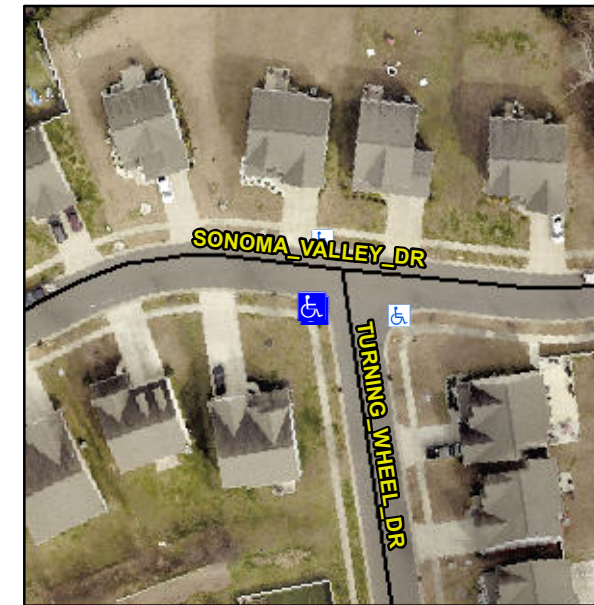
**Not Found, R304.5.1**

Compliance	Description	Data	Compliance	Description	Data
N/A	Ramp Length (in)	72.5	Yes	Ramp Slope (%)	7.1
No	Ramp Width (in)	47.0	Yes	Ramp XSlope (%)	1.0
N/A	Flare Type LT	N/A	N/A	Flare Type RT	N/A
N/A	Flare Slope LT (%)	N/A	N/A	Flare Slope RT (%)	N/A
N/A	Flare Traversable LT?	N/A	N/A	Flare Traversable RT?	N/A
N/A	Landing Length (in)	N/A	N/A	DWS Provided?	N/A
N/A	Landing Width (in)	N/A	N/A	DWS Contrast?	N/A
N/A	Landing Slope (%)	N/A	N/A	DWS Length (in)	N/A
N/A	Landing X Slope (%)	N/A	N/A	DWS Full Width?	N/A
N/A	Landing Curb? (Y/N)	N/A	N/A	DWS Offset (in)	N/A
N/A	Shared Landing?	N/A			
N/A	Gutter Ponding?	N/A	N/A	Gutter Slope (%)	N/A
N/A	Gutter Lip Ht (in)	N/A	N/A	Gutter X Slope (%)	N/A
N/A	Painted X Walk1?	No	N/A	Painted X Walk2?	No
	X Walk 1 Direction	To E		X Walk 2 Direction	To N
N/A	X Walk 1 Width (in)	N/A	N/A	X Walk 2 Width (in)	N/A
	X Walk 1 Slope (%)	2.9		X Walk 2 Slope (%)	3.5
	X Walk 1 X Slope (%)	1.7		X Walk 2 X Slope (%)	4.4

N/A	Ramp inside XWalk1?	N/A	N/A	Ramp inside XWalk2?	N/A
	Road Slope (%)	0.9	N/A	Clear Space?	N/A
	Road X Slope (%)	4.7	N/A	Clear Space to XWalk (in)	N/A
N/A	Any Obstructions?	N/A	N/A	Storm Grate/Utility Hazard?	N/A
	Obstruction Type			Storm Grate/Utility Type	
		N/A			N/A
			Yes	Surface Condition? (G/P)	Good

**Remove & Replace Curb Ramp With Two New Directional Ramps or Equivalent.**

Total Cost: \$ 3200.00
