Access Compliance Report

Public Rights-of-Way

(Curb Ramps)

Intersection ID: 14468	Main Street: E_TREMONT_AV	Cross Street: EUCLID_AV	Location: E
ADA ID: E4F2DCCC3C19	Ramp Type: PerpDiag	Initial Pass/Fail: Fail	Overall Compliance: No
Severity Score: 25			
Codes/Mitigation Info/Possible Solution		Field Measurements/Component Compliance

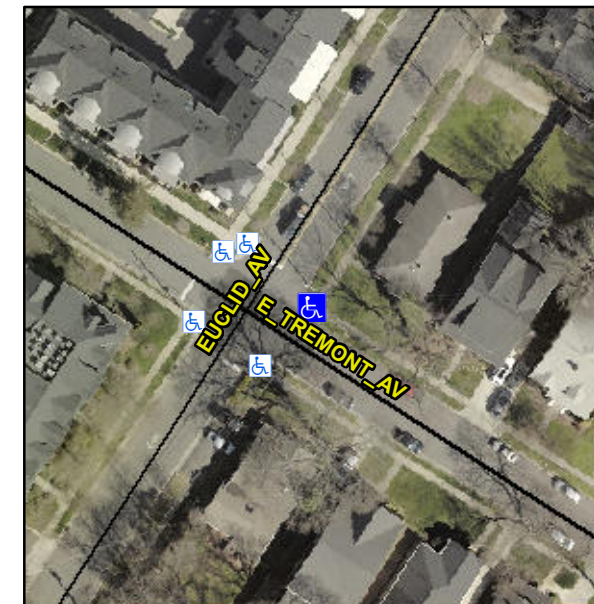
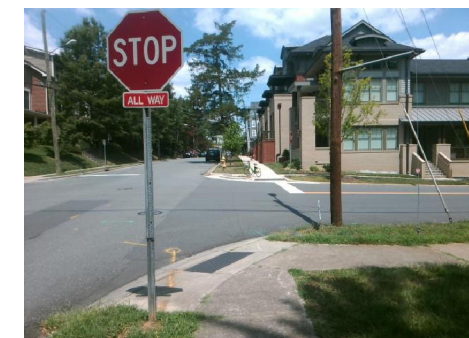
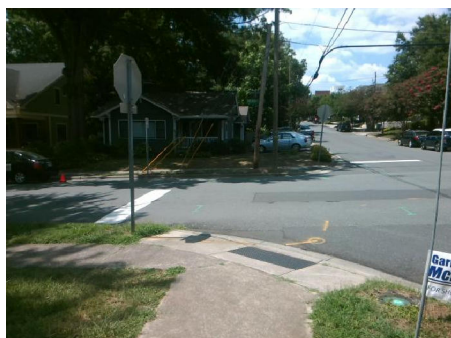
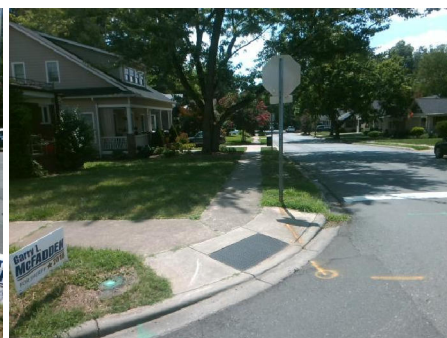
Not Found, R304.2.2

Compliance	Description	Data	Compliance	Description	Data
N/A	Ramp Length (in)	71.0	No	Ramp Slope (%)	13.8
Yes	Ramp Width (in)	48.0	Yes	Ramp XSlope (%)	2.0
N/A	Flare Type LT	N/A	N/A	Flare Type RT	N/A
N/A	Flare Slope LT (%)	N/A	N/A	Flare Slope RT (%)	N/A
N/A	Flare Traversable LT?	N/A	N/A	Flare Traversable RT?	N/A
N/A	Landing Length (in)	N/A	N/A	DWS Provided?	N/A
N/A	Landing Width (in)	N/A	N/A	DWS Contrast?	N/A
N/A	Landing Slope (%)	N/A	N/A	DWS Length (in)	N/A
N/A	Landing X Slope (%)	N/A	N/A	DWS Full Width?	N/A
N/A	Landing Curb? (Y/N)	N/A	N/A	DWS Offset (in)	N/A
N/A	Shared Landing?	N/A			
N/A	Gutter Ponding?	N/A	N/A	Gutter Slope (%)	N/A
N/A	Gutter Lip Ht (in)	1.0	N/A	Gutter X Slope (%)	N/A
N/A	Painted X Walk1?	No	N/A	Painted X Walk2?	No
	X Walk 1 Direction	To NW		X Walk 2 Direction	To SW
N/A	X Walk 1 Width (in)	N/A	N/A	X Walk 2 Width (in)	N/A
	X Walk 1 Slope (%)	7.0		X Walk 2 Slope (%)	2.8
	X Walk 1 X Slope (%)	5.5		X Walk 2 X Slope (%)	4.5

N/A	Ramp inside XWalk1?	N/A	N/A	Ramp inside XWalk2?	N/A
	Road Slope (%)	2.2	N/A	Clear Space?	N/A
	Road X Slope (%)	10.5	N/A	Clear Space to XWalk (in)	N/A
N/A	Any Obstructions?	N/A	N/A	Storm Grate/Utility Hazard?	N/A
	Obstruction Type			Storm Grate/Utility Type	
		N/A			N/A
		Yes		Surface Condition? (G/P)	Good

Remove & Replace Curb Ramp With Two New Directional Ramps or Equivalent.

Total Cost: \$ 3200.00
