| Intersection ID: 23692 | Main Street: BRANDON_FOREST_DR | Cross Street: BREUSTER_DR | Location: | NW |
| ADA ID: E4F3B5A416B1 | Ramp Type: PerpDiag | Initial Pass/Fail: Fail | Overall Compliance: No | Severity Score: 12.5 |

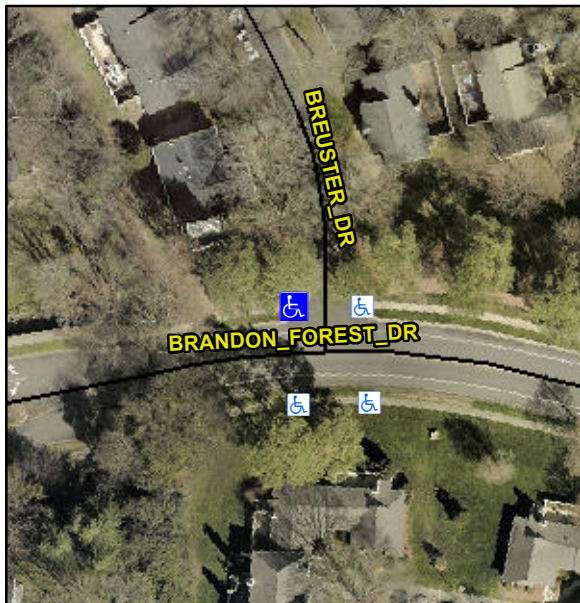
| Codes/Mitigation Info/Possible Solution | | | Field Measurements/Component Compliance | | | | | |
|---|---|---|---|---|---|---|---|---|
| | Remove & Replace Curb Ramp With Two New Directional Ramps or Equivalent. | | N/A | Ramp Length (in) | 33.0 | No | Ramp Slope (%) | 8.4 |
| | | | Yes | Ramp Width (in) | 48.0 | Yes | Ramp XSlope (%) | 0.9 |
| PROW/ADA: | | R304.2.2 | N/A | Shared Landing? | N/A | | | |
