Access Compliance Report

Public Rights-of-Way

(Curb Ramps)

Intersection ID: 10028555	Main Street: HOLLY_HILL_FARM_RD	Cross Street: N/A	Location: W
ADA ID: E4F6E8F4662E	Ramp Type: Perp	Initial Pass/Fail: Fail	Overall Compliance: No
Severity Score: 13.75			
Codes/Mitigation Info/Possible Solution		Field Measurements/Component Compliance

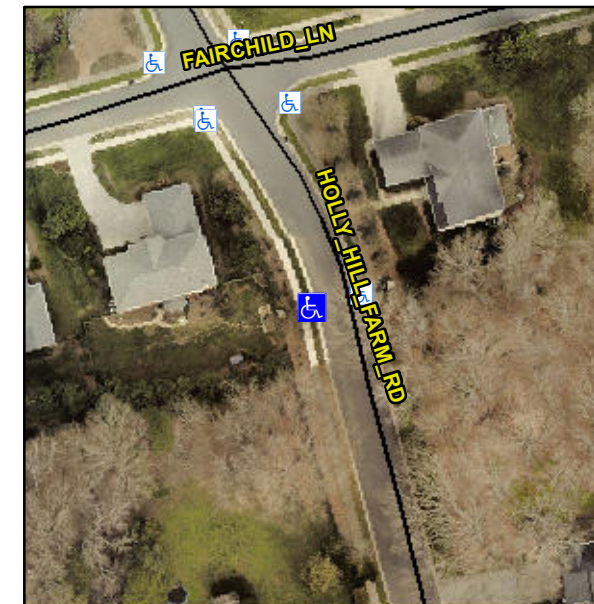
Compliance	Description	Data	Compliance	Description	Data
N/A	Ramp Length (in)	70.5	No	Ramp Slope (%)	9.8
Yes	Ramp Width (in)	48.0	Yes	Ramp XSlope (%)	3.2
N/A	Flare Type LT	N/A	N/A	Flare Type RT	N/A
N/A	Flare Slope LT (%)	N/A	N/A	Flare Slope RT (%)	N/A
N/A	Flare Traversable LT?	N/A	N/A	Flare Traversable RT?	N/A
N/A	Landing Length (in)	N/A	N/A	DWS Provided?	N/A
N/A	Landing Width (in)	N/A	N/A	DWS Contrast?	N/A
N/A	Landing Slope (%)	N/A	N/A	DWS Length (in)	N/A
N/A	Landing X Slope (%)	N/A	N/A	DWS Full Width?	N/A
N/A	Landing Curb? (Y/N)	N/A	N/A	DWS Offset (in)	N/A
N/A	Shared Landing?	N/A			
N/A	Gutter Ponding?	N/A	N/A	Gutter Slope (%)	N/A
N/A	Gutter Lip Ht (in)	N/A	N/A	Gutter X Slope (%)	N/A
N/A	Painted X Walk1?	No	N/A	Painted X Walk2?	N/A
	X Walk 1 Direction	To E		X Walk 2 Direction	N/A
N/A	X Walk 1 Width (in)	N/A	N/A	X Walk 2 Width (in)	N/A
	X Walk 1 Slope (%)	0.5		X Walk 2 Slope (%)	N/A
	X Walk 1 X Slope (%)	3.4		X Walk 2 X Slope (%)	N/A

N/A	Ramp inside XWalk1?	N/A	N/A	Ramp inside XWalk2?	N/A
	Road Slope (%)	N/A	N/A	Clear Space?	N/A
	Road X Slope (%)	N/A	N/A	Clear Space to XWalk (in)	N/A
N/A	Any Obstructions?	N/A	N/A	Storm Grate/Utility Hazard?	N/A
	Obstruction Type			Storm Grate/Utility Type	
		N/A			N/A
			Yes	Surface Condition? (G/P)	Good

Possible Solutions:

Remove & Replace Entire Ramp.

R304.2.2

\$ 1850.00
