# Access Compliance Report

## Public Rights-of-Way

### (Curb Ramps)

| Intersection ID: 14600 | Main Street: DILWORTH_RD | Cross Street: DILWORTH_RD_EAST | Location: SW |

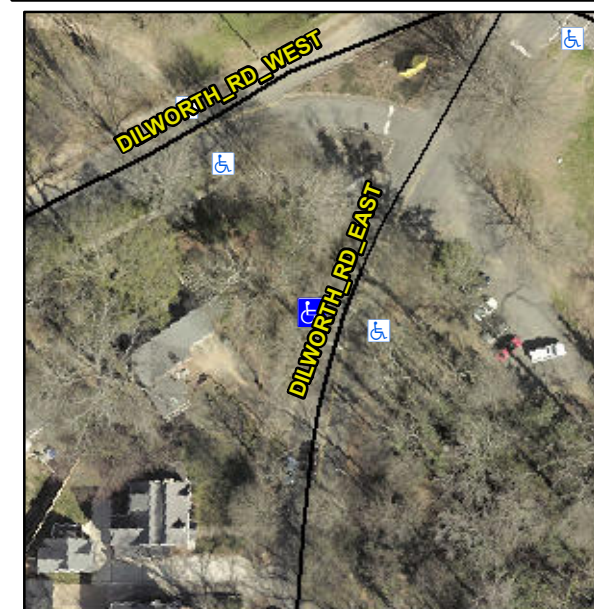
| ADA ID: E4FAC9C08A56 | Ramp Type: Perp | Initial Pass/Fail: Fail | Overall Compliance: No |
| Severity Score: 13.75 | | | |

**R304.2.2, R304.5.3**

| Compliance | Description | Data | Compliance | Description | Data |
|---|---|---|---|---|---|
| N/A | Ramp Length (in) | 114.0 | No | Ramp Slope (%) | 9.7 |
| Yes | Ramp Width (in) | 48.0 | No | Ramp XSlope (%) | 3.7 |
| N/A | Gutter Ponding? | Yes | N/A | Gutter Slope (%) | N/A |

**Remove & Replace Entire Ramp.**

Total Cost: \$ 1850.00
