4.7

Intersection ID: 11084 Main Street: E 25TH ST **Cross Street: EVERETT PL** Location:

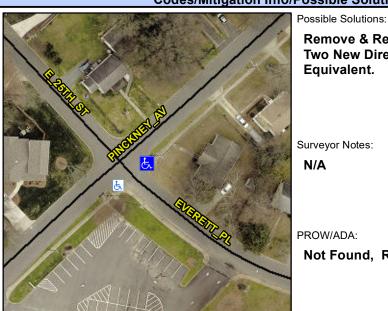
No	Ramp Width (in)	39.0	No	BlendTrans XSlope (%)	7.8
N/A	Flare Type LT	N/A	N/A	Flare Type RT	N/A
N/A	Flare Slope LT (%)	N/A	N/A	Flare Slope RT (%)	N/A
N/A	Flare Traversable LT?	N/A	N/A	Flare Traversable RT?	N/A
N/A	Landing Length (in)	N/A	N/A	DWS Provided?	N/A
N/A	Landing Width (in)	N/A	N/A	DWS Contrast?	N/A
N/A	Landing Slope (%)	N/A	N/A	DWS Length (in)	N/A
N/A	Landing X Slope (%)	N/A	N/A	DWS Full Width?	N/A
N/A	Landing Curb? (Y/N)	N/A	N/A	DWS Offset (in)	N/A
N/A	Shared Landing?	N/A			
N/A	Gutter Ponding?	N/A	N/A	Gutter Slope (%)	N/A
N/A	Gutter Lip Ht (in)	N/A	N/A	Gutter X Slope (%)	N/A
N/A	Painted X Walk1?	No	N/A	Painted X Walk2?	N/A
	X Walk 1 Direction	To SW		X Walk 2 Direction	N/A
	X Walk 1 Width (in)	N/A		X Walk 2 Width (in)	N/A
	X Walk 1 Slope (%)	10.7		X Walk 2 Slope (%)	N/A
	X Walk 1 X Slope (%)	2.4		X Walk 2 X Slope (%)	N/A
N/A	Ramp inside XWalk1?	N/A	N/A	Ramp inside XWalk2?	N/A
	Road Slope (%)	2.4		Clear Space?	N/A

PROW/ADA:
