Access Compliance Report

Public Rights-of-Way

(Curb Ramps)

Intersection ID: 44009	Main Street: REA_RD	Cross Street: DEMAINE_DR	Location: SW
ADA ID: E4FFFB59E44E	Ramp Type: Perp	Initial Pass/Fail: Fail	Overall Compliance: No
Codes/Mitigation Info/Possible Solution		Field Measurements/Component Compliance	
Severity Score: 12.5

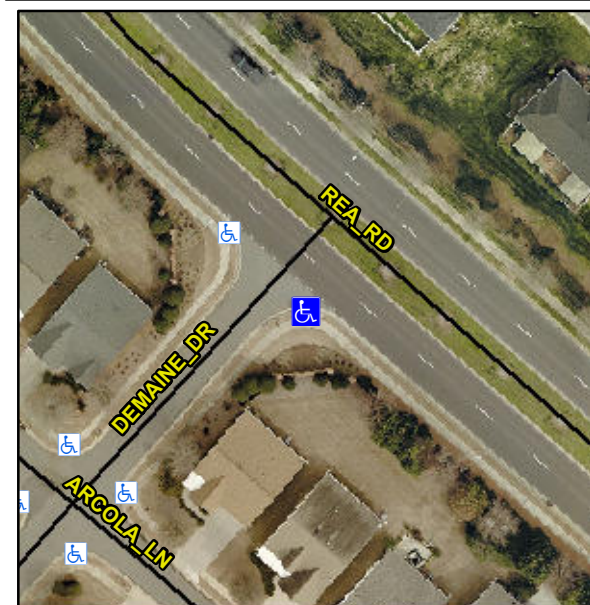
Not Found, R304.5.3

Compliance	Description	Data	Compliance	Description	Data
N/A	Ramp Length (in)	102.0	Yes	Ramp Slope (%)	6.6
Yes	Ramp Width (in)	60.0	No	Ramp XSlope (%)	5.8
N/A	Flare Type LT	N/A	N/A	Flare Type RT	N/A
N/A	Flare Slope LT (%)	N/A	N/A	Flare Slope RT (%)	N/A
N/A	Flare Traversable LT?	N/A	N/A	Flare Traversable RT?	N/A
N/A	Landing Length (in)	N/A	N/A	DWS Provided?	N/A
N/A	Landing Width (in)	N/A	N/A	DWS Contrast?	N/A
N/A	Landing Slope (%)	N/A	N/A	DWS Length (in)	N/A
N/A	Landing X Slope (%)	N/A	N/A	DWS Full Width?	N/A
N/A	Landing Curb? (Y/N)	N/A	N/A	DWS Offset (in)	N/A
N/A	Shared Landing?	N/A			
N/A	Gutter Ponding?	N/A	N/A	Gutter Slope (%)	N/A
N/A	Gutter Lip Ht (in)	N/A	N/A	Gutter X Slope (%)	N/A
N/A	Painted X Walk1?	No	N/A	Painted X Walk2?	N/A
	X Walk 1 Direction	To NW		X Walk 2 Direction	N/A
N/A	X Walk 1 Width (in)	N/A	N/A	X Walk 2 Width (in)	N/A
	X Walk 1 Slope (%)	3.1		X Walk 2 Slope (%)	N/A
	X Walk 1 X Slope (%)	0.8		X Walk 2 X Slope (%)	N/A

N/A	Ramp inside XWalk1?	N/A	N/A	Ramp inside XWalk2?	N/A
	Road Slope (%)	N/A	N/A	Clear Space?	N/A
	Road X Slope (%)	N/A	N/A	Clear Space to XWalk (in)	N/A
N/A	Any Obstructions?	N/A	N/A	Storm Grate/Utility Hazard?	N/A
	Obstruction Type			Storm Grate/Utility Type	
		N/A			N/A
			Yes	Surface Condition? (G/P)	Good

Possible Solutions:

Remove & Replace Entire Ramp.
