Good

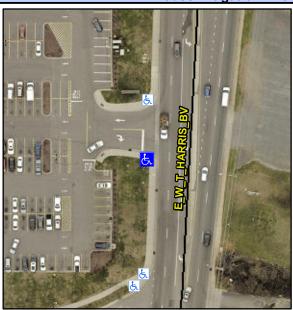
EWTHARRISBV Street 1 Name Stop Condition-Street 1 None **ENTRANCE** Street 2 Name Stop Condition-Street 2 StopSign

Possible Solutions: Remove & Replace Curb Ramp With Two New Directional Ramps or Equivalent. Surveyor Notes: N/A PROW/ADA: R304.3.2
