# Access Compliance Report

## Public Rights-of-Way

### (Curb Ramps)

| Intersection ID: 50601 | Main Street: LUSTERLEAF_HOLLY_RD | Cross Street: HEARTLEAF_RD | Location: SE |

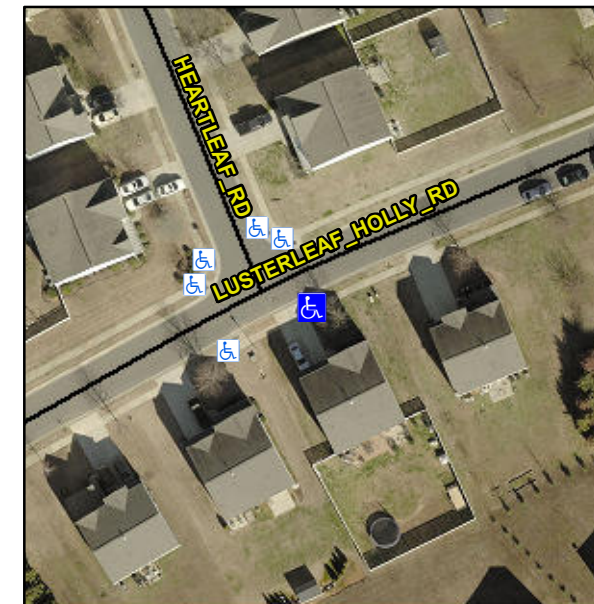
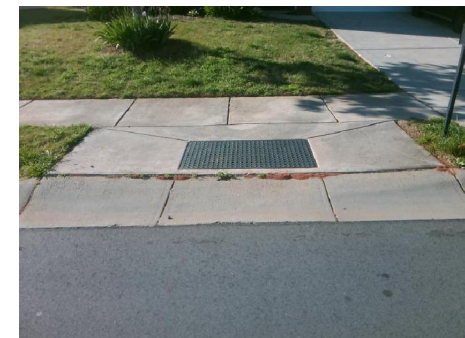
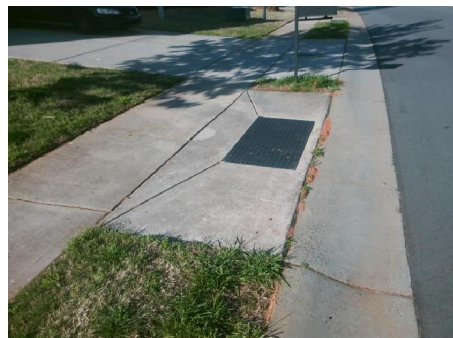
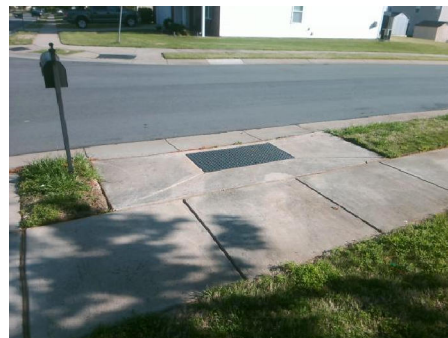
**CURB LIP 0.5**

**Not Found, R304.2.1, R305.2, R304.5.4**

| Compliance | Description | Data | Compliance | Description | Data |
|---|---|---|---|---|---|
| No | Landing Length (in) | 47.0 | Yes | DWS Provided? | Yes |
| N/A | Landing Curb? (Y/N) | No | No | DWS Offset (in) | 5.0 |
| Yes | Gutter Ponding? | No | No | Gutter Slope (%) | 6.3 |
| | | | No | Curb Slope (%) | 12.2 |

**Remove & Replace Curb Ramp With Two New Directional Ramps or Equivalent. Remove & Replace Gutter.**
