Access Compliance Report

Public Rights-of-Way

(Curb Ramps)

Intersection ID: 29172	Main Street: BOXELDER_LN	Cross Street: WHITEBARK_CT	Location: S
ADA ID: E50E8A2E09CC	Ramp Type: PerpDiag	Initial Pass/Fail: Fail	Overall Compliance: No
			Severity Score: 18.75

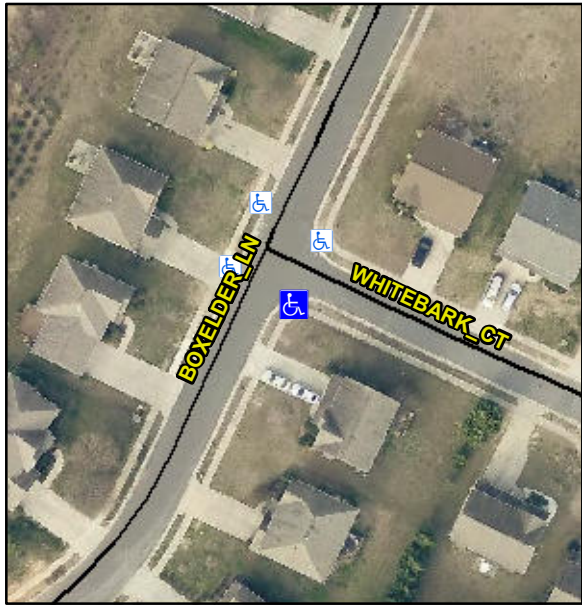
Possible Solutions:		Compliance	Description	Data	Compliance	Description	Data
	Remove & Replace Curb Ramp With Two New Directional Ramps or Equivalent.		N/A	Ramp Length (in)	45.5	Yes	Ramp Slope (%)	7.5
			No	Ramp Width (in)	35.0	No	Ramp XSlope (%)	2.9
			N/A	Flare Type LT	N/A	N/A	Flare Type RT	N/A
			N/A	Flare Slope LT (%)	N/A	N/A	Flare Slope RT (%)	N/A
			N/A	Flare Traversable LT?	N/A	N/A	Flare Traversable RT?	N/A
			N/A	Landing Length (in)	N/A	N/A	DWS Provided?	N/A
			N/A	Landing Width (in)	N/A	N/A	DWS Contrast?	N/A
			N/A	Landing Slope (%)	N/A	N/A	DWS Length (in)	N/A
			N/A	Landing X Slope (%)	N/A	N/A	DWS Full Width?	N/A
Surveyor Notes:		N/A	N/A	Landing Curb? (Y/N)	N/A	N/A	DWS Offset (in)	N/A
PROW/ADA:		Not Found, R304.5.1, R304.5.3	N/A	Shared Landing?	N/A			
			N/A	Gutter Ponding?	N/A	N/A	Gutter Slope (%)	N/A

N/A	Gutter Lip Ht (in)	N/A	N/A	Gutter X Slope (%)	N/A
			N/A	Painted X Walk1?	No	N/A	Painted X Walk2?	No
				X Walk 1 Direction	To NE		X Walk 2 Direction	To NW
			N/A	X Walk 1 Width (in)	N/A	N/A	X Walk 2 Width (in)	N/A
				X Walk 1 Slope (%)	0.2		X Walk 2 Slope (%)	5.5
				X Walk 1 X Slope (%)	1.8		X Walk 2 X Slope (%)	0.8
			N/A	Ramp inside XWalk1?	N/A	N/A	Ramp inside XWalk2?	N/A
				Road Slope (%)	2.6	N/A	Clear Space?	N/A
				Road X Slope (%)	2.5	N/A	Clear Space to XWalk (in)	N/A
			N/A	Any Obstructions?	N/A	N/A	Storm Grate/Utility Hazard?	N/A
				Obstruction Type			Storm Grate/Utility Type	
					N/A			N/A
						Yes	Surface Condition? (G/P)	Good
Total Cost:		\$ 3200.00
