Access Compliance Report

Public Rights-of-Way

(Curb Ramps)

Intersection ID: 13259	Main Street: CENTRAL_AV	Cross Street: CHATHAM_AV	Location: NW
ADA ID: E5109B9ACD68	Ramp Type: PerpDiag	Initial Pass/Fail: Fail	Overall Compliance: No
			Severity Score: 13.75

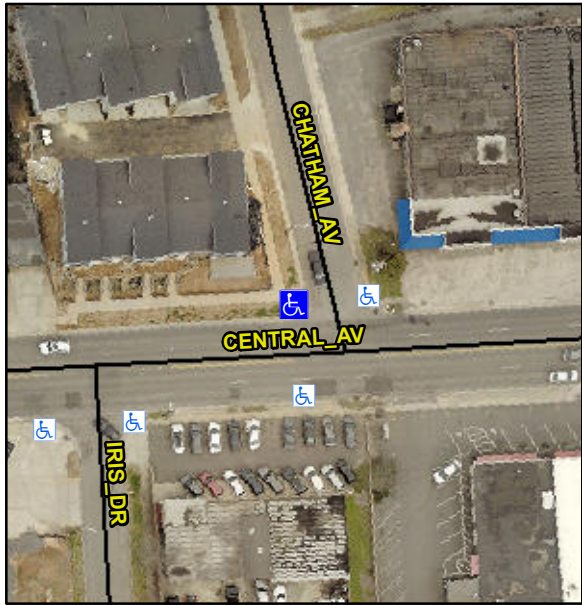
Possible Solutions:		Compliance	Description	Data	Compliance	Description	Data
	Remove & Replace Curb Ramp With Two New Directional Ramps or Equivalent.		N/A	Ramp Length (in)	53.0	No	Ramp Slope (%)	8.8
			Yes	Ramp Width (in)	57.0	No	Ramp XSlope (%)	4.4
			N/A	Flare Type LT	N/A	N/A	Flare Type RT	N/A
			N/A	Flare Slope LT (%)	N/A	N/A	Flare Slope RT (%)	N/A
			N/A	Flare Traversable LT?	N/A	N/A	Flare Traversable RT?	N/A
			N/A	Landing Length (in)	N/A	N/A	DWS Provided?	N/A
			N/A	Landing Width (in)	N/A	N/A	DWS Contrast?	N/A
			N/A	Landing Slope (%)	N/A	N/A	DWS Length (in)	N/A
			N/A	Landing X Slope (%)	N/A	N/A	DWS Full Width?	N/A
Surveyor Notes:		N/A	N/A	Landing Curb? (Y/N)	N/A	N/A	DWS Offset (in)	N/A
PROW/ADA:		Not Found, R304.2.2, R304.5.3	N/A	Shared Landing?	N/A			
			N/A	Gutter Ponding?	N/A	N/A	Gutter Slope (%)	N/A

N/A	Gutter Lip Ht (in)	N/A	N/A	Gutter X Slope (%)	N/A
			N/A	Painted X Walk1?	No	N/A	Painted X Walk2?	No
				X Walk 1 Direction	To S		X Walk 2 Direction	To E
			N/A	X Walk 1 Width (in)	N/A	N/A	X Walk 2 Width (in)	N/A
				X Walk 1 Slope (%)	0.3		X Walk 2 Slope (%)	7.6
				X Walk 1 X Slope (%)	4.9		X Walk 2 X Slope (%)	0.5
			N/A	Ramp inside XWalk1?	N/A	N/A	Ramp inside XWalk2?	N/A
				Road Slope (%)	3.8	N/A	Clear Space?	N/A
				Road X Slope (%)	3.7	N/A	Clear Space to XWalk (in)	N/A
			N/A	Any Obstructions?	N/A	N/A	Storm Grate/Utility Hazard?	N/A
				Obstruction Type			Storm Grate/Utility Type	
					N/A			N/A
						Yes	Surface Condition? (G/P)	Good
Street 1 Name		CENTRAL AV						
Stop Condition-Street 2		None						
Street 2 Name		CHATHAM AV						
Stop Condition-Street 1		StopSign						
Total Cost:		\$ 3200.00
