# Access Compliance Report

## Public Rights-of-Way

### (Curb Ramps)

Intersection ID: 13263	Main Street: MCCLINTOCK_RD	Cross Street: THE_PLAZA	Location: SE
ADA ID: E513D4F7A4E0	Ramp Type: Perp	Initial Pass/Fail: Fail	Overall Compliance: No
Severity Score: 8.75			
Codes/Mitigation Info/Possible Solution		Field Measurements/Component Compliance

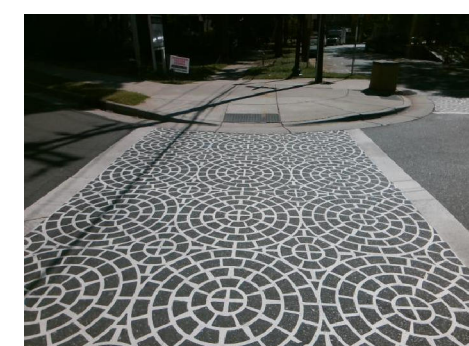
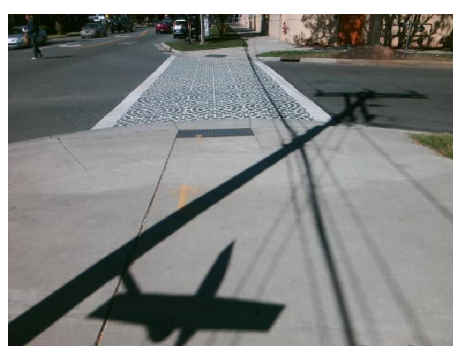
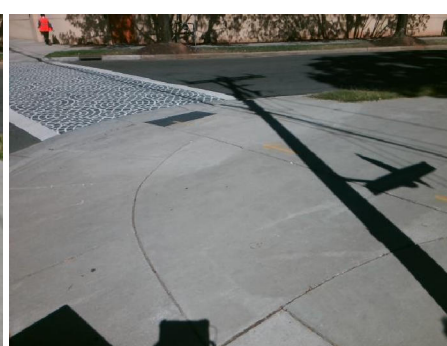
Compliance	Description	Data	Compliance	Description	Data
N/A	Ramp Length (in)	60.0	Yes	Ramp Slope (%)	7.8
No	Ramp Width (in)	47.0	Yes	Ramp XSlope (%)	0.4
N/A	Flare Type LT	N/A	N/A	Flare Type RT	N/A
N/A	Flare Slope LT (%)	N/A	N/A	Flare Slope RT (%)	N/A
N/A	Flare Traversable LT?	N/A	N/A	Flare Traversable RT?	N/A
N/A	Landing Length (in)	N/A	N/A	DWS Provided?	N/A
N/A	Landing Width (in)	N/A	N/A	DWS Contrast?	N/A
N/A	Landing Slope (%)	N/A	N/A	DWS Length (in)	N/A
N/A	Landing X Slope (%)	N/A	N/A	DWS Full Width?	N/A
N/A	Landing Curb? (Y/N)	N/A	N/A	DWS Offset (in)	N/A
N/A	Shared Landing?	N/A			
N/A	Gutter Ponding?	N/A	N/A	Gutter Slope (%)	N/A
N/A	Gutter Lip Ht (in)	N/A	N/A	Gutter X Slope (%)	N/A
N/A	Painted X Walk1?	Yes	N/A	Painted X Walk2?	N/A
	X Walk 1 Direction	To N		X Walk 2 Direction	N/A
N/A	X Walk 1 Width (in)	154.0	N/A	X Walk 2 Width (in)	N/A
	X Walk 1 Slope (%)	2.5		X Walk 2 Slope (%)	N/A
	X Walk 1 X Slope (%)	2.0		X Walk 2 X Slope (%)	N/A

N/A	Ramp inside XWalk1?	Yes	N/A	Ramp inside XWalk2?	N/A
	Road Slope (%)	N/A	N/A	Clear Space?	N/A
	Road X Slope (%)	N/A	N/A	Clear Space to XWalk (in)	N/A
N/A	Any Obstructions?	N/A	N/A	Storm Grate/Utility Hazard?	N/A
	Obstruction Type			Storm Grate/Utility Type	
		N/A			N/A
		Yes		Surface Condition? (G/P)	Good

Possible Solutions:

**Remove & Replace Entire Ramp.**
