Access Compliance Report

Public Rights-of-Way

(Curb Ramps)

Intersection ID: 30003	Main Street: CHEPSTOW_CT	Cross Street: KEMPSFORD_DR	Location: S
ADA ID: E5191E17259F	Ramp Type: PerpDiag	Initial Pass/Fail: Fail	Overall Compliance: No
Severity Score: 1.25			
Codes/Mitigation Info/Possible Solution		Field Measurements/Component Compliance

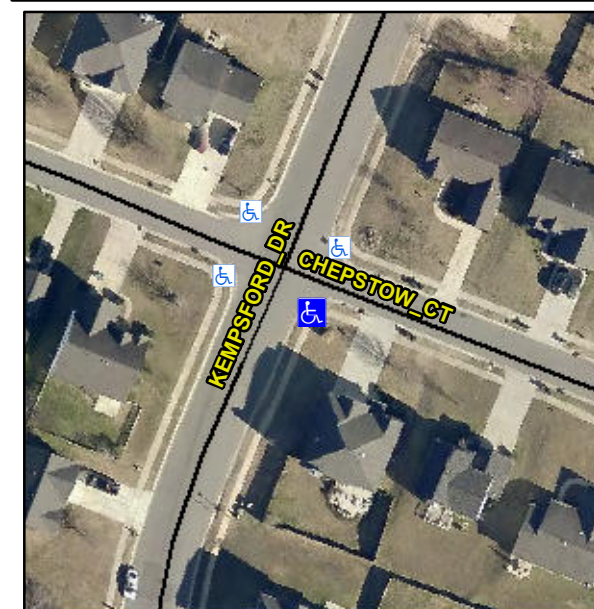
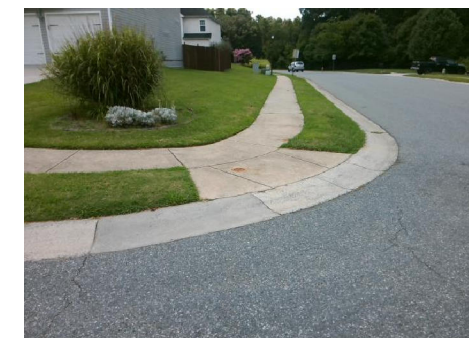
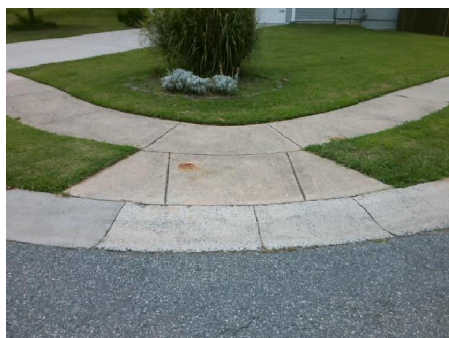
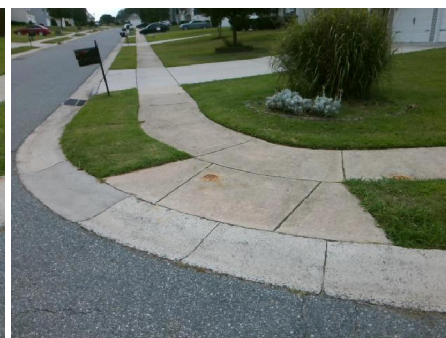
Not Found, R304.5.3

Compliance	Description	Data	Compliance	Description	Data
N/A	Ramp Length (in)	47.0	Yes	Ramp Slope (%)	5.0
Yes	Ramp Width (in)	48.0	No	Ramp XSlope (%)	3.1
N/A	Flare Type LT	N/A	N/A	Flare Type RT	N/A
N/A	Flare Slope LT (%)	N/A	N/A	Flare Slope RT (%)	N/A
N/A	Flare Traversable LT?	N/A	N/A	Flare Traversable RT?	N/A
N/A	Landing Length (in)	N/A	N/A	DWS Provided?	N/A
N/A	Landing Width (in)	N/A	N/A	DWS Contrast?	N/A
N/A	Landing Slope (%)	N/A	N/A	DWS Length (in)	N/A
N/A	Landing X Slope (%)	N/A	N/A	DWS Full Width?	N/A
N/A	Landing Curb? (Y/N)	N/A	N/A	DWS Offset (in)	N/A
N/A	Shared Landing?	N/A			
N/A	Gutter Ponding?	N/A	N/A	Gutter Slope (%)	N/A
N/A	Gutter Lip Ht (in)	N/A	N/A	Gutter X Slope (%)	N/A
N/A	Painted X Walk1?	No	N/A	Painted X Walk2?	No
	X Walk 1 Direction	To NE		X Walk 2 Direction	To NW
N/A	X Walk 1 Width (in)	N/A	N/A	X Walk 2 Width (in)	N/A
	X Walk 1 Slope (%)	1.4		X Walk 2 Slope (%)	1.3
	X Walk 1 X Slope (%)	1.3		X Walk 2 X Slope (%)	1.8

N/A	Ramp inside XWalk1?	N/A	N/A	Ramp inside XWalk2?	N/A
	Road Slope (%)	0.4	N/A	Clear Space?	N/A
	Road X Slope (%)	0.5	N/A	Clear Space to XWalk (in)	N/A
N/A	Any Obstructions?	N/A	N/A	Storm Grate/Utility Hazard?	N/A
	Obstruction Type			Storm Grate/Utility Type	
		N/A			N/A
		Yes		Surface Condition? (G/P)	Good

Remove & Replace Curb Ramp With Two New Directional Ramps or Equivalent.
