Access Compliance Report

Public Rights-of-Way

(Curb Ramps)

Intersection ID: 6874	Main Street: CINDY_LN	Cross Street: GRASSET_AV	Location: NE
ADA ID: E5194654CB51	Ramp Type: Directional1	Initial Pass/Fail: Fail	Overall Compliance: No
		Severity Score: 1.25

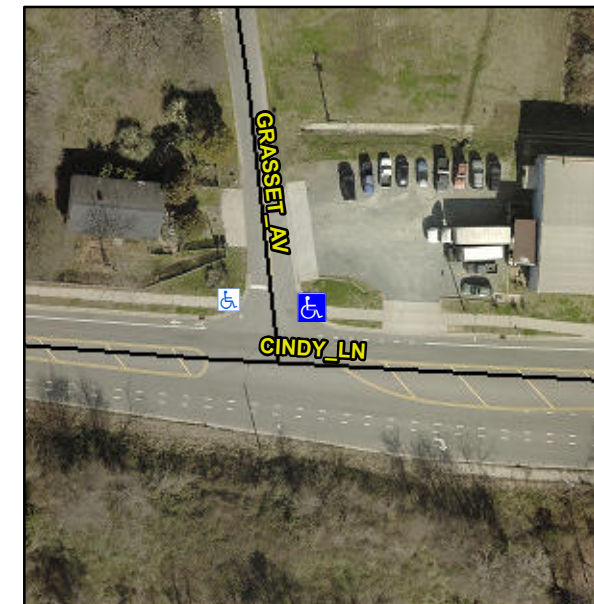
R304.5.3

Compliance	Description	Data	Compliance	Description	Data
N/A	Ramp Length (in)	64.0	N/A	Grade Break?	N/A
Yes	Ramp Width (in)	68.0	N/A	Grade Break Slope (%)	0.0
Yes	Ramp Slope (%)	6.7	N/A	Grade Break XSlope (%)	0.0
No	Ramp XSlope (%)	2.2			
N/A	Flare Type LT	N/A	N/A	Flare Type RT	N/A
N/A	Flare Slope LT (%)	N/A	N/A	Flare Slope RT (%)	0.0
N/A	Flare Traversable LT?	N/A	N/A	Flare Traversable RT?	N/A
N/A	Landing Length (in)	0.0	N/A	DWS Provided?	N/A
N/A	Landing Width (in)	0.0	N/A	DWS Contrast?	N/A
N/A	Landing Slope (%)	0.0	N/A	DWS Length (in)	N/A
N/A	Landing X Slope (%)	0.0	N/A	DWS Full Width?	N/A
N/A	Landing Curb? (Y/N)	N/A	N/A	DWS Offset LT (in)	N/A
N/A	Shared Landing?	N/A	N/A	DWS Offset RT (in)	N/A
N/A	Gutter Ponding?	0.0	N/A	Gutter Slope (%)	N/A
N/A	Gutter Lip Ht (in)	0.0	N/A	Gutter X Slope (%)	N/A
N/A	Painted X Walk1?	No		Road Slope (%)	4.4
	X Walk 1 Direction	To W		Road X Slope (%)	3.3
	X Walk 1 Width (in)	N/A		Clear Space?	N/A

X Walk 1 Slope (%)	4.4	N/A	Clear Space to XWalk (in)	N/A
	X Walk 1 X Slope (%)	3.3	N/A	Storm Grate/Utility Hazard?	N/A
N/A	Ramp inside XWalk1?	N/A		Storm Grate/Utility Type	
N/A	Any Obstructions?	N/A			N/A
	Obstruction Type		Yes	Surface Condition? (G/P)	Good
			N/A	Curb Slope (%)	14.5

Remove & Replace Entire Ramp.
