Access Compliance Report

Public Rights-of-Way

(Curb Ramps)

| Intersection ID: 13368 | Main Street: CENTRAL_AV | Cross Street: LOGIE_AV | Location: NE |

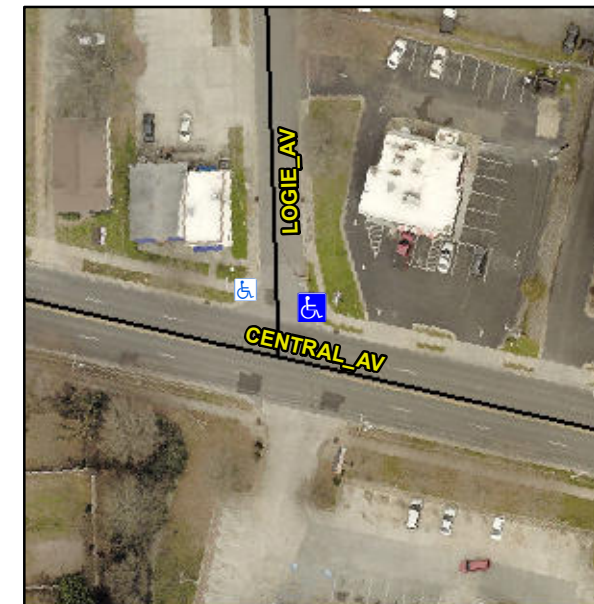
| ADA ID: E51A9F701A4C | Ramp Type: Perp | Initial Pass/Fail: Fail | Overall Compliance: No |

Not Found, R304.5.1, R304.5.3

| Compliance | Description | Data | Compliance | Description | Data |
|---|---|---|---|---|---|
| No | Ramp Width (in) | 32.0 | No | Ramp XSlope (%) | 5.9 |

Remove & Replace Entire Ramp.
