## **Access Compliance Report Public Rights-of-Way** (Curb Ramps)

Intersection ID: 19936 Main Street: ARCHDALE DR **Cross Street: CHERRYCREST LN** Location: ADA ID: E51B54827F7D Ramp Type: PerpDiag Initial Pass/Fail: Fail **Overall Compliance: No** Severity Score: 33.75

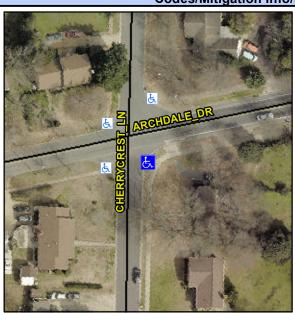
Field Measurements/Component Compliance								
	Compli	ance [	Description	Data Compliance		ance	Description	Data
	N/A	Ramp I	_ength (in)	75.0	Yes	Ramp	Slope (%)	6.6
	No	Ramp \	Width (in)	46.0	No	Ramp	XSlope (%)	7.1
	N/A	Flare T	ype LT	N/A	N/A	Flare	Type RT	N/A
	N/A	Flare S	Slope LT (%)	N/A	N/A	Flare	Slope RT (%)	N/A
	N/A	Flare T	raversable LT?	N/A	N/A	Flare	Traversable RT?	N/A
	N/A	Landin	g Length (in)	N/A	N/A	DWS	Provided?	N/A
	N/A	Landin	g Width (in)	N/A	N/A	DWS	Contrast?	N/A
	N/A	Landin	g Slope (%)	N/A	N/A	DWS	Length (in)	N/A
	N/A	Landing	g X Slope (%)	N/A	N/A	DWS	Full Width?	N/A
	N/A	Landing	g Curb? (Y/N)	N/A	N/A	DWS	Offset (in)	N/A
	N/A	Shared	Landing?	N/A				
	N/A	Gutter	Ponding?	N/A	N/A	Gutte	r Slope (%)	N/A
	N/A	Gutter	Lip Ht (in)	N/A	N/A	Gutte	r X Slope (%)	N/A
	N/A	Painted	I X Walk1?	No	N/A	Painte	ed X Walk2?	No
		X Walk	1 Direction	To N		X Wal	k 2 Direction	To W
	N/A	X Walk	1 Width (in)	N/A	N/A	X Wal	k 2 Width (in)	N/A

X Walk	1 Slope (%)	3.1		X Wal	k 2 Slope (%)	3.3
		X Walk	1 X Slope (%)	4.0		X Wal	k 2 X Slope (%)	5.0
	N/A	Ramp i	nside XWalk1?	N/A	N/A	Ramp	inside XWalk2?	N/A
		Road S	Slope (%)	5.6	N/A	Clear	Space?	N/A
		Road X	(Slope (%)	0.2	N/A	Clear	Space to XWalk (in)	N/A
	N/A	Any Ob	structions?	N/A	N/A	Storm	Grate/Utility Hazard?	N/A
		Obstru	ction Type			Storm	Grate/Utility Type	
				N/A				N/A
					Yes	Surfac	ce Condition? (G/P)	Good
	0		The same

Possible Solutions: Remove & Replace Curb Ramp With Two New Directional Ramps or Equivalent. Surveyor Notes: N/A PROW/ADA: Not Found, R304.5.1, R304.5.3
