Access Compliance Report

Public Rights-of-Way

(Curb Ramps)

Intersection ID: 5905	Main Street: HELLEBORE_RD	Cross Street: PIMPERNEL_RD	Location: NW
ADA ID: E52342FB6B2A	Ramp Type: Perp	Initial Pass/Fail: Fail	Overall Compliance: No
Severity Score: 12.5			
Codes/Mitigation Info/Possible Solution		Field Measurements/Component Compliance

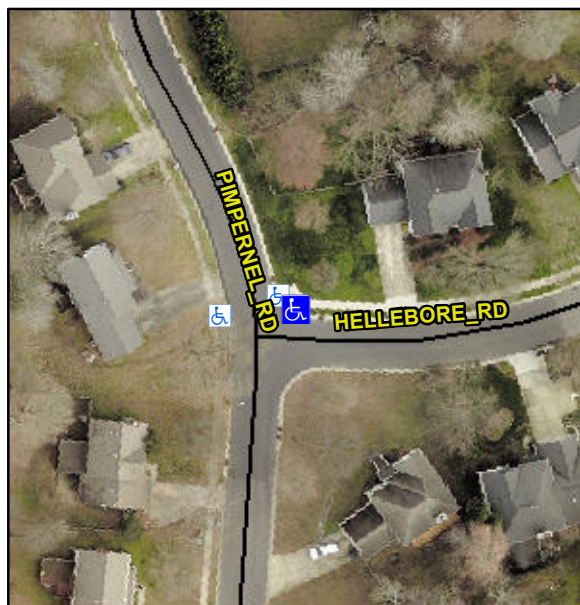
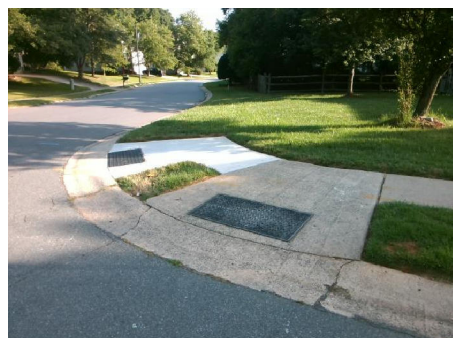
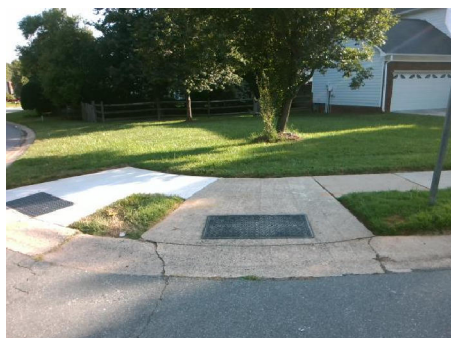
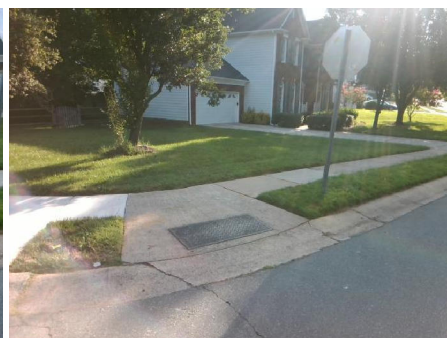
R304.2.2

Compliance	Description	Data	Compliance	Description	Data
N/A	Ramp Length (in)	47.0	No	Ramp Slope (%)	10.8
Yes	Ramp Width (in)	72.0	Yes	Ramp XSlope (%)	0.6
N/A	Flare Type LT	N/A	N/A	Flare Type RT	N/A
N/A	Flare Slope LT (%)	N/A	N/A	Flare Slope RT (%)	N/A
N/A	Flare Traversable LT?	N/A	N/A	Flare Traversable RT?	N/A
N/A	Landing Length (in)	N/A	N/A	DWS Provided?	N/A
N/A	Landing Width (in)	N/A	N/A	DWS Contrast?	N/A
N/A	Landing Slope (%)	N/A	N/A	DWS Length (in)	N/A
N/A	Landing X Slope (%)	N/A	N/A	DWS Full Width?	N/A
N/A	Landing Curb? (Y/N)	N/A	N/A	DWS Offset (in)	N/A
N/A	Shared Landing?	N/A			
N/A	Gutter Ponding?	N/A	N/A	Gutter Slope (%)	N/A
N/A	Gutter Lip Ht (in)	N/A	N/A	Gutter X Slope (%)	N/A
N/A	Painted X Walk1?	No	N/A	Painted X Walk2?	N/A
	X Walk 1 Direction	To S		X Walk 2 Direction	N/A
N/A	X Walk 1 Width (in)	N/A	N/A	X Walk 2 Width (in)	N/A
	X Walk 1 Slope (%)	4.5		X Walk 2 Slope (%)	N/A
	X Walk 1 X Slope (%)	0.0		X Walk 2 X Slope (%)	N/A

N/A	Ramp inside XWalk1?	N/A	N/A	Ramp inside XWalk2?	N/A
	Road Slope (%)	N/A	N/A	Clear Space?	N/A
	Road X Slope (%)	N/A	N/A	Clear Space to XWalk (in)	N/A
N/A	Any Obstructions?	N/A	N/A	Storm Grate/Utility Hazard?	N/A
	Obstruction Type			Storm Grate/Utility Type	
		N/A			N/A
			Yes	Surface Condition? (G/P)	Good

Remove & Replace Entire Ramp.
