## Access Compliance Report Public Rights-of-Way (Curb Ramps)

Intersection ID: 21435 Main Street: SARDIS\_LN Cross Street: DUNEDIN\_LN Location: SW

ADA ID: E523CE80334D Ramp Type: Directional1 Initial Pass/Fail: Fail Overall Compliance: No Severity Score: 12.5

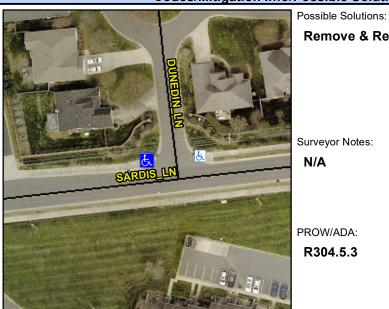
Field Measur	ements/C	ompor	ient Compliance	
Compli	ance Description	Data	Compl	liance Description	Data
N/A	Ramp Length (in)	110.0	N/A	Grade Break?	N/A
Yes	Ramp Width (in)	59.0	N/A	Grade Break Slope (%)	0.0
Yes	Ramp Slope (%)	6.4	N/A	Grade Break XSlope (%)	0.0
No	Ramp XSlope (%)	5.8			
N/A	Flare Type LT	N/A	N/A	Flare Type RT	N/A
N/A	Flare Slope LT (%)	N/A	N/A	Flare Slope RT (%)	0.0
N/A	Flare Traversable LT?	N/A	N/A	Flare Traversable RT?	N/A
N/A	Landing Length (in)	0.0	N/A	DWS Provided?	N/A
N/A	Landing Width (in)	0.0	N/A	DWS Contrast?	N/A
N/A	Landing Slope (%)	0.0	N/A	DWS Length (in)	N/A
N/A	Landing X Slope (%)	0.0	N/A	DWS Full Width?	N/A
N/A	Landing Curb? (Y/N)	N/A	N/A	DWS Offset LT (in)	N/A
N/A	Shared Landing?	N/A	N/A	DWS Offset RT (in)	N/A
N/A	Gutter Ponding?	0.0	N/A	Gutter Slope (%)	N/A
N/A	Gutter Lip Ht (in)	0.0	N/A	Gutter X Slope (%)	N/A
N/A	Painted X Walk1?	No		Road Slope (%)	0.7
	X Walk 1 Direction	To NE		Road X Slope (%)	3.1

X Walk 1 Width (in)	N/A		Clear Space?	N/A
	X Walk 1 Slope (%)	0.7	N/A	Clear Space to XWalk (in)	N/A
	X Walk 1 X Slope (%)	3.1	N/A	Storm Grate/Utility Hazard?	N/A
N/A	Ramp inside XWalk1?	N/A		Storm Grate/Utility Type	
N/A	Any Obstructions?	N/A			N/A
	Obstruction Type		Yes	Surface Condition? (G/P)	Good
		N/A	N/A	Curb Slope (%)	5.4

Remove & Replace Entire Ramp.  Yes Yes No N/A N/A Surveyor Notes: N/A N/A N/A N/A PROW/ADA: N/A R304.5.3 N/A N/A N/A N/A N/A N/A N/A		
Yes	Remove & Replace Entire Ramp.	N/A
No N/A N/A Surveyor Notes: N/A N/A N/A N/A N/A N/A PROW/ADA: N/A R304.5.3 N/A N/A N/A		Yes
Surveyor Notes: N/A N/A N/A N/A N/A N/A N/A N/A PROW/ADA: N/A R304.5.3 N/A N/A		Yes
N/A Surveyor Notes: N/A N/A N/A N/A N/A N/A PROW/ADA: N/A R304.5.3 N/A N/A N/A		No
Surveyor Notes: N/A N/A N/A N/A N/A N/A N/A PROW/ADA: N/A R304.5.3 N/A N/A		N/A
N/A N/A N/A N/A N/A N/A N/A N/A PROW/ADA: N/A R304.5.3 N/A N/A N/A		N/A
N/A N/A N/A PROW/ADA: N/A R304.5.3 N/A N/A N/A	Surveyor Notes:	N/A
PROW/ADA: N/A R304.5.3 N/A N/A N/A	N/A	N/A
PROW/ADA: N/A R304.5.3 N/A N/A N/A		N/A
PROW/ADA:  R304.5.3  N/A  N/A  N/A		N/A
R304.5.3 N/A N/A N/A		N/A
N/A N/A	PROW/ADA:	N/A
N/A	R304.5.3	N/A
		N/A
N/A		N/A
		N/A

Total Cost:	\$ 1600.00
