Access Compliance Report

Public Rights-of-Way

(Curb Ramps)

Intersection ID: 21910	Main Street: CARMEL_RD	Cross Street: COLONY_RD	Location: SW
ADA ID: E5249FCD2298	Ramp Type: ParaDiag	Initial Pass/Fail: Fail	Overall Compliance: No
		Severity Score: 12.5

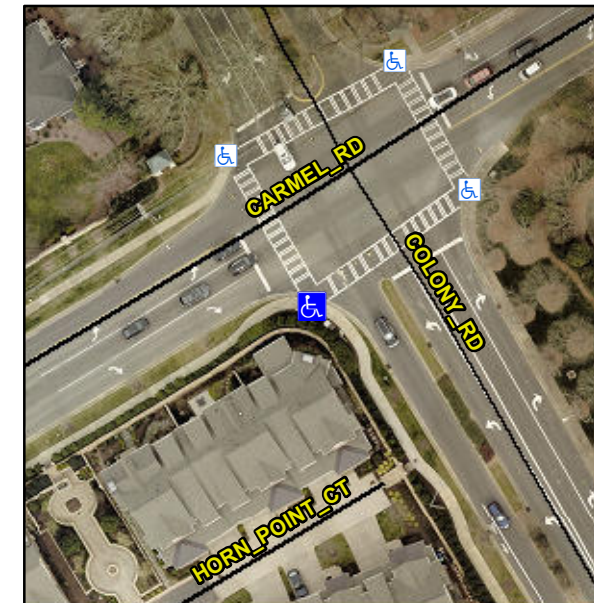
RT RP < 5%

Compliance	Description	Data	Compliance	Description	Data
N/A	Ramp Length LT (in)	68.0	N/A	Ramp Length RT (in)	61.0
Yes	Ramp Width LT (in)	72.0	Yes	Ramp Width RT (in)	72.0
No	Ramp Slope LT (%)	11.8	Yes	Ramp Slope RT (%)	3.0
Yes	Ramp XSlope LT (%)	1.7	Yes	Ramp XSlope RT (%)	1.6
N/A	Landing Length (in)	N/A	N/A	DWS Provided?	N/A
N/A	Landing Width (in)	N/A	N/A	DWS Contrast?	N/A
N/A	Landing Slope (%)	N/A	N/A	DWS Length (in)	N/A
N/A	Landing X Slope (%)	N/A	N/A	DWS Full Width?	N/A
N/A	Landing Curb? (Y/N)	N/A	N/A	DWS Offset (in)	N/A
N/A	Shared Landing?	N/A			
N/A	Gutter Ponding?	N/A	N/A	Gutter Slope (%)	N/A
N/A	Gutter Lip Ht (in)	N/A	N/A	Gutter X Slope (%)	N/A
N/A	Painted X Walk1?	Yes	N/A	Painted X Walk2?	Yes
	X Walk 1 Direction	To NE		X Walk 2 Direction	To NW
N/A	X Walk 1 Width (in)	111.0	N/A	X Walk 2 Width (in)	109.0
	X Walk 1 Slope (%)	3.9		X Walk 2 Slope (%)	0.4
	X Walk 1 X Slope (%)	0.9		X Walk 2 X Slope (%)	5.8

N/A	Ramp inside XWalk1?	Yes	N/A	Ramp inside XWalk2?	Yes
	Road Slope (%)	2.9	N/A	Clear Space?	N/A
	Road X Slope (%)	3.2	N/A	Clear Space to XWalk (in)	N/A
N/A	Any Obstructions?	N/A	N/A	Storm Grate/Utility Hazard?	N/A
	Obstruction Type			Storm Grate/Utility Type	
		N/A			N/A
			Yes	Surface Condition? (G/P)	Good
			N/A	Curb Slope (%)	7.9

Remove & Replace Curb Ramp With Two New Directional Ramps or Equivalent.
