Access Compliance Report

Public Rights-of-Way

(Curb Ramps)

Intersection ID: 10144	Main Street: FONTANA_AV	Cross Street: VOGEL_CT	Location: NW
ADA ID: E525A847E5E3	Ramp Type: Perp	Initial Pass/Fail: Fail	Overall Compliance: No
Severity Score: 25			
Codes/Mitigation Info/Possible Solution		Field Measurements/Component Compliance

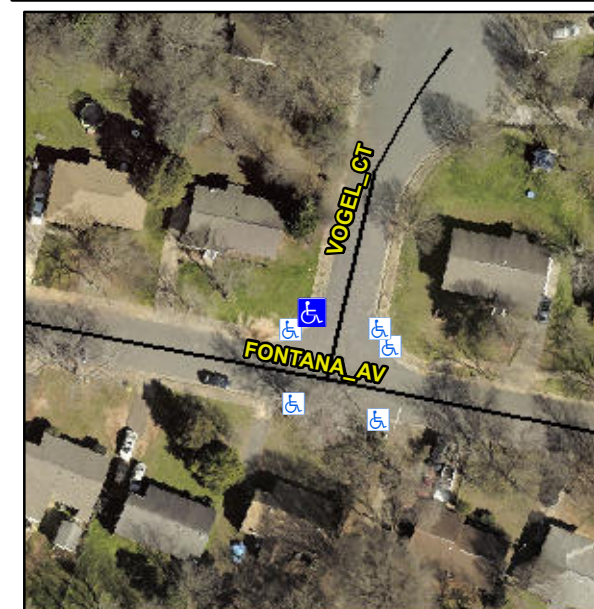
Not Found, R304.2.2

Compliance	Description	Data	Compliance	Description	Data
N/A	Ramp Length (in)	59.0	No	Ramp Slope (%)	12.9
Yes	Ramp Width (in)	48.0	Yes	Ramp XSlope (%)	1.6
N/A	Flare Type LT	N/A	N/A	Flare Type RT	N/A
N/A	Flare Slope LT (%)	N/A	N/A	Flare Slope RT (%)	N/A
N/A	Flare Traversable LT?	N/A	N/A	Flare Traversable RT?	N/A
N/A	Landing Length (in)	N/A	N/A	DWS Provided?	N/A
N/A	Landing Width (in)	N/A	N/A	DWS Contrast?	N/A
N/A	Landing Slope (%)	N/A	N/A	DWS Length (in)	N/A
N/A	Landing X Slope (%)	N/A	N/A	DWS Full Width?	N/A
N/A	Landing Curb? (Y/N)	N/A	N/A	DWS Offset (in)	N/A
N/A	Shared Landing?	N/A			
N/A	Gutter Ponding?	N/A	N/A	Gutter Slope (%)	N/A
N/A	Gutter Lip Ht (in)	0.5	N/A	Gutter X Slope (%)	N/A
N/A	Painted X Walk1?	No	N/A	Painted X Walk2?	N/A
	X Walk 1 Direction	To SE		X Walk 2 Direction	N/A
N/A	X Walk 1 Width (in)	N/A	N/A	X Walk 2 Width (in)	N/A
	X Walk 1 Slope (%)	6.7		X Walk 2 Slope (%)	N/A
	X Walk 1 X Slope (%)	0.8		X Walk 2 X Slope (%)	N/A

N/A	Ramp inside XWalk1?	N/A	N/A	Ramp inside XWalk2?	N/A
	Road Slope (%)	N/A	N/A	Clear Space?	N/A
	Road X Slope (%)	N/A	N/A	Clear Space to XWalk (in)	N/A
N/A	Any Obstructions?	N/A	N/A	Storm Grate/Utility Hazard?	N/A
	Obstruction Type			Storm Grate/Utility Type	
		N/A			N/A
			Yes	Surface Condition? (G/P)	Good

Remove & Replace Entire Ramp.
