Access Compliance Report

Public Rights-of-Way

(Curb Ramps)

Intersection ID: 52487	Main Street: WHITEHALL_EXECUTIVE_CENTER_DR	Cross Street: ORLICK_DR	Location: E
ADA ID: E52E228CAF95	Ramp Type: Perp	Initial Pass/Fail: Fail	Overall Compliance: No
Severity Score: 1.25			
Codes/Mitigation Info/Possible Solution		Field Measurements/Component Compliance

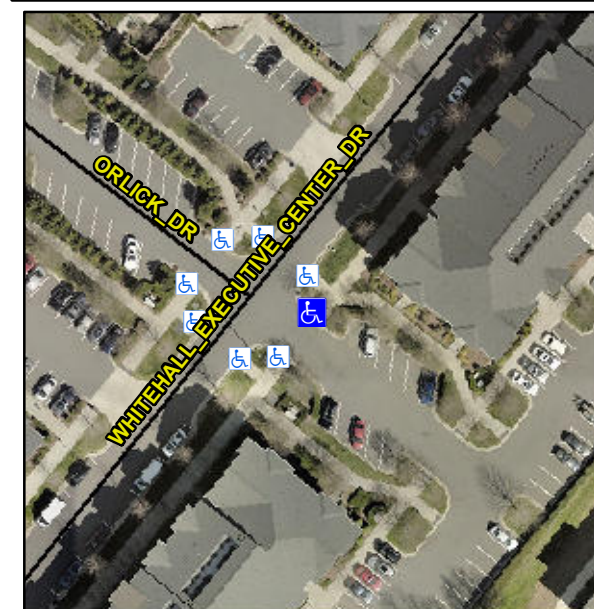
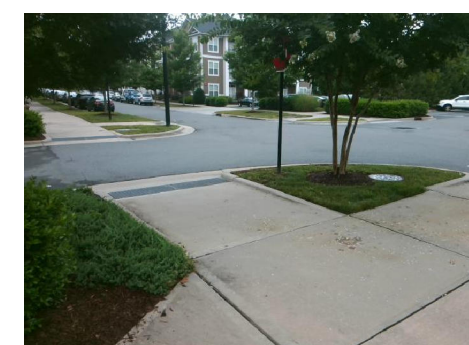
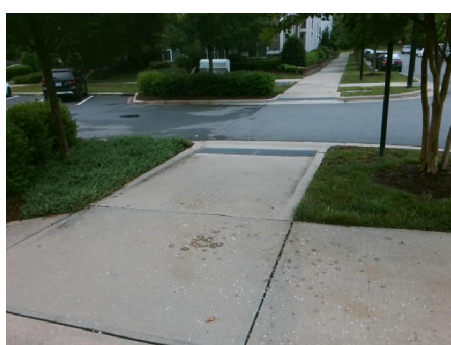
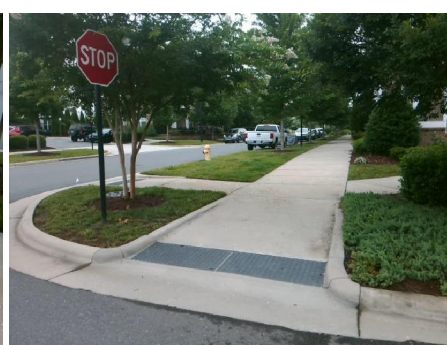
Not Found, R304.5.3

Compliance	Description	Data	Compliance	Description	Data
N/A	Ramp Length (in)	144.0	Yes	Ramp Slope (%)	6.5
Yes	Ramp Width (in)	89.0	No	Ramp XSlope (%)	2.8
N/A	Flare Type LT	N/A	N/A	Flare Type RT	N/A
N/A	Flare Slope LT (%)	N/A	N/A	Flare Slope RT (%)	N/A
N/A	Flare Traversable LT?	N/A	N/A	Flare Traversable RT?	N/A
N/A	Landing Length (in)	N/A	N/A	DWS Provided?	N/A
N/A	Landing Width (in)	N/A	N/A	DWS Contrast?	N/A
N/A	Landing Slope (%)	N/A	N/A	DWS Length (in)	N/A
N/A	Landing X Slope (%)	N/A	N/A	DWS Full Width?	N/A
N/A	Landing Curb? (Y/N)	N/A	N/A	DWS Offset (in)	N/A
N/A	Shared Landing?	N/A			
N/A	Gutter Ponding?	N/A	N/A	Gutter Slope (%)	N/A
N/A	Gutter Lip Ht (in)	N/A	N/A	Gutter X Slope (%)	N/A
N/A	Painted X Walk1?	No	N/A	Painted X Walk2?	N/A
	X Walk 1 Direction	To SW		X Walk 2 Direction	N/A
N/A	X Walk 1 Width (in)	N/A	N/A	X Walk 2 Width (in)	N/A
	X Walk 1 Slope (%)	0.7		X Walk 2 Slope (%)	N/A
	X Walk 1 X Slope (%)	2.6		X Walk 2 X Slope (%)	N/A

N/A	Ramp inside XWalk1?	N/A	N/A	Ramp inside XWalk2?	N/A
	Road Slope (%)	N/A	N/A	Clear Space?	N/A
	Road X Slope (%)	N/A	N/A	Clear Space to XWalk (in)	N/A
N/A	Any Obstructions?	N/A	N/A	Storm Grate/Utility Hazard?	N/A
	Obstruction Type			Storm Grate/Utility Type	
		N/A			N/A
		Yes		Surface Condition? (G/P)	Good

Remove & Replace Entire Ramp.
