Access Compliance Report

Public Rights-of-Way

(Curb Ramps)

Intersection ID: 29979		Main Street: REIGATE_RD		Cross Street: ALBANS_LN		Location: NE			
ADA ID: E5393775F5D3		Ramp Type: PerpDiag		Initial Pass/Fail: Fail		Overall Compliance: No		Severity Score: 10	
Codes/Mitigation Info/Possible Solution				Field Measurements/Component Compliance

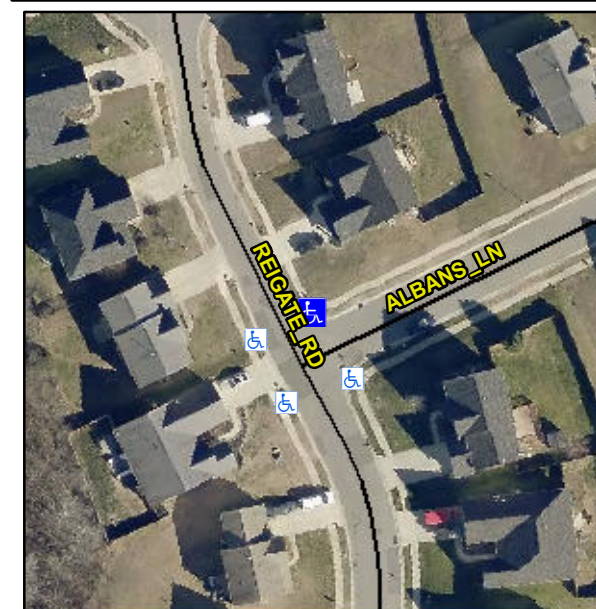
Not Found, R304.5.1, R304.5.3

Compliance	Description	Data	Compliance	Description	Data
N/A	Ramp Length (in)	46.0	Yes	Ramp Slope (%)	5.2
No	Ramp Width (in)	40.5	No	Ramp XSlope (%)	3.6
N/A	Flare Type LT	N/A	N/A	Flare Type RT	N/A
N/A	Flare Slope LT (%)	N/A	N/A	Flare Slope RT (%)	N/A
N/A	Flare Traversable LT?	N/A	N/A	Flare Traversable RT?	N/A
N/A	Landing Length (in)	N/A	N/A	DWS Provided?	N/A
N/A	Landing Width (in)	N/A	N/A	DWS Contrast?	N/A
N/A	Landing Slope (%)	N/A	N/A	DWS Length (in)	N/A
N/A	Landing X Slope (%)	N/A	N/A	DWS Full Width?	N/A
N/A	Landing Curb? (Y/N)	N/A	N/A	DWS Offset (in)	N/A
N/A	Shared Landing?	N/A			
N/A	Gutter Ponding?	N/A	N/A	Gutter Slope (%)	N/A
N/A	Gutter Lip Ht (in)	N/A	N/A	Gutter X Slope (%)	N/A
N/A	Painted X Walk1?	No	N/A	Painted X Walk2?	No
	X Walk 1 Direction	To W		X Walk 2 Direction	To S
N/A	X Walk 1 Width (in)	N/A	N/A	X Walk 2 Width (in)	N/A
	X Walk 1 Slope (%)	0.0		X Walk 2 Slope (%)	1.5
	X Walk 1 X Slope (%)	1.9		X Walk 2 X Slope (%)	0.3

N/A	Ramp inside XWalk1?	N/A	N/A	Ramp inside XWalk2?	N/A
	Road Slope (%)	0.3	N/A	Clear Space?	N/A
	Road X Slope (%)	0.6	N/A	Clear Space to XWalk (in)	N/A
N/A	Any Obstructions?	N/A	N/A	Storm Grate/Utility Hazard?	N/A
	Obstruction Type			Storm Grate/Utility Type	
		N/A			N/A
		Yes		Surface Condition? (G/P)	Good

Possible Solutions:

Remove & Replace Curb Ramp With Two New Directional Ramps or Equivalent.
