Access Compliance Report Public Rights-of-Way (Curb Ramps)

Intersection ID: 11109 Main Street: COLEBROOK_RD Cross Street: MEADOWCLIFF_DR Location: E

ADA ID: E542A4F2DD06 Ramp Type: BlendTrans1 Initial Pass/Fail: Fail Overall Compliance: No Severity Score: 8.75

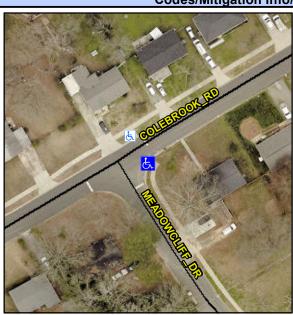
Not Found, R304.5.1

Compliance Description D		Data	Comp	liance Description
N/A	Ramp Length (in)	51.5	Yes	BlendTrans Slope (%)
No	Ramp Width (in)	47.0	Yes	BlendTrans XSlope (%)
N/A	Flare Type LT	N/A	N/A	Flare Type RT
N/A	Flare Slope LT (%)	N/A	N/A	Flare Slope RT (%)
N/A	Flare Traversable LT?	N/A	N/A	Flare Traversable RT?
N/A	Landing Length (in)	N/A	N/A	DWS Provided?
N/A	Landing Width (in)	N/A	N/A	DWS Contrast?
N/A	Landing Slope (%)	N/A	N/A	DWS Length (in)
N/A	Landing X Slope (%)	N/A	N/A	DWS Full Width?
N/A	Landing Curb? (Y/N)	N/A	N/A	DWS Offset (in)
N/A	Shared Landing?	N/A		
N/A	Gutter Ponding?	N/A	N/A	Gutter Slope (%)
N/A	Gutter Lip Ht (in)	N/A	N/A	Gutter X Slope (%)
N/A	Painted X Walk1?	No	N/A	Painted X Walk2?
	X Walk 1 Direction	To NW		X Walk 2 Direction
	X Walk 1 Width (in)	N/A		X Walk 2 Width (in)
	X Walk 1 Slope (%)	1.8		X Walk 2 Slope (%)
	X Walk 1 X Slope (%)	1.4		X Walk 2 X Slope (%)
N/A	Ramp inside XWalk1?	N/A	N/A	Ramp inside XWalk2?

Road Slope (%)	1.4		Clear Space?
	Road X Slope (%)	1.8	N/A	Clear Space to XWalk (in)
N/A	Any Obstructions?	N/A	N/A	Storm Grate/Utility Hazard?
	Obstruction Type			Storm Grate/Utility Type
		N/A

Remove & Replace Curb Ramp With
Two New Directional Ramps or
Equivalent.
