Access Compliance Report

Public Rights-of-Way

(Curb Ramps)

Intersection ID: 44008	Main Street: ARCOLA_LN	Cross Street: DEMAINE_DR	Location: E
ADA ID: E5460450A226	Ramp Type: PerpDiag	Initial Pass/Fail: Fail	Overall Compliance: No
Severity Score: 21.25			
Codes/Mitigation Info/Possible Solution		Field Measurements/Component Compliance

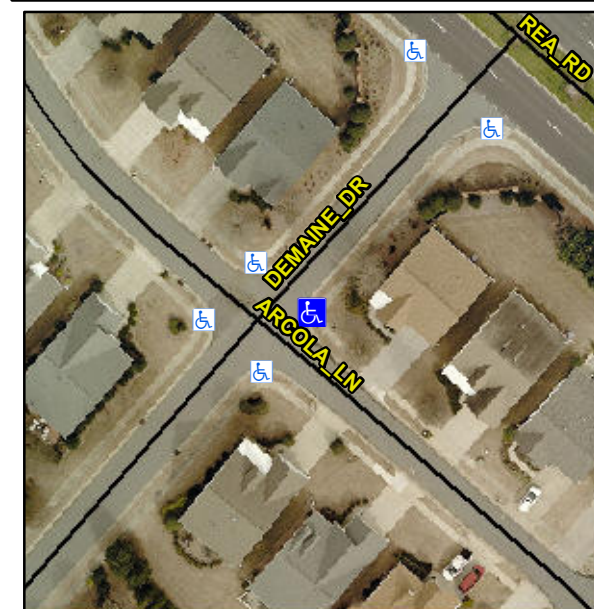
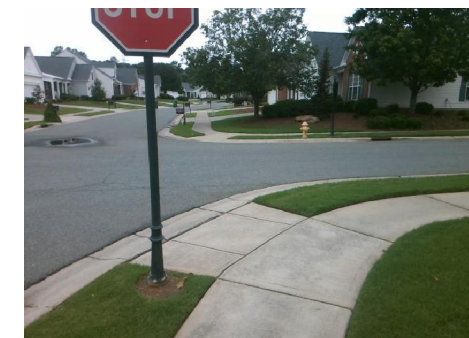
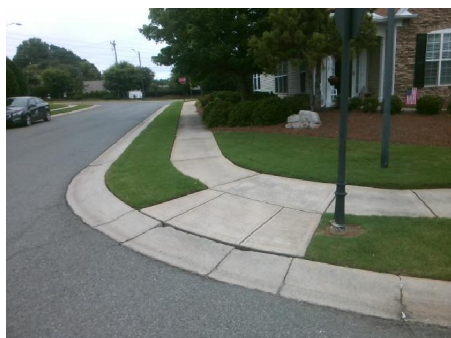
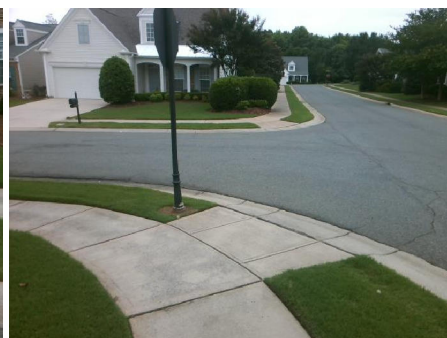
Not Found, R304.5.1, R304.5.3

Compliance	Description	Data	Compliance	Description	Data
N/A	Ramp Length (in)	46.0	Yes	Ramp Slope (%)	8.1
No	Ramp Width (in)	46.0	No	Ramp XSlope (%)	6.3
N/A	Flare Type LT	N/A	N/A	Flare Type RT	N/A
N/A	Flare Slope LT (%)	N/A	N/A	Flare Slope RT (%)	N/A
N/A	Flare Traversable LT?	N/A	N/A	Flare Traversable RT?	N/A
N/A	Landing Length (in)	N/A	N/A	DWS Provided?	N/A
N/A	Landing Width (in)	N/A	N/A	DWS Contrast?	N/A
N/A	Landing Slope (%)	N/A	N/A	DWS Length (in)	N/A
N/A	Landing X Slope (%)	N/A	N/A	DWS Full Width?	N/A
N/A	Landing Curb? (Y/N)	N/A	N/A	DWS Offset (in)	N/A
N/A	Shared Landing?	N/A			
N/A	Gutter Ponding?	N/A	N/A	Gutter Slope (%)	N/A
N/A	Gutter Lip Ht (in)	N/A	N/A	Gutter X Slope (%)	N/A
N/A	Painted X Walk1?	No	N/A	Painted X Walk2?	No
	X Walk 1 Direction	To NW		X Walk 2 Direction	To SW
N/A	X Walk 1 Width (in)	N/A	N/A	X Walk 2 Width (in)	N/A
	X Walk 1 Slope (%)	2.9		X Walk 2 Slope (%)	0.5
	X Walk 1 X Slope (%)	2.6		X Walk 2 X Slope (%)	3.9

N/A	Ramp inside XWalk1?	N/A	N/A	Ramp inside XWalk2?	N/A
	Road Slope (%)	5.8	N/A	Clear Space?	N/A
	Road X Slope (%)	0.9	N/A	Clear Space to XWalk (in)	N/A
N/A	Any Obstructions?	N/A	N/A	Storm Grate/Utility Hazard?	N/A
	Obstruction Type			Storm Grate/Utility Type	
		N/A			N/A
			Yes	Surface Condition? (G/P)	Good

Remove & Replace Curb Ramp With Two New Directional Ramps or Equivalent.

Total Cost: \$ 3200.00
