# Access Compliance Report

## Public Rights-of-Way

### (Curb Ramps)

Intersection ID: 32307	Main Street: BRIDGEVIEW_LN	Cross Street: NEW_PROVIDENCE_LN	Location: NE
ADA ID: E5495037689C	Ramp Type: PerpDiag	Initial Pass/Fail: Fail	Overall Compliance: No
Severity Score: 22.5			
Codes/Mitigation Info/Possible Solution		Field Measurements/Component Compliance

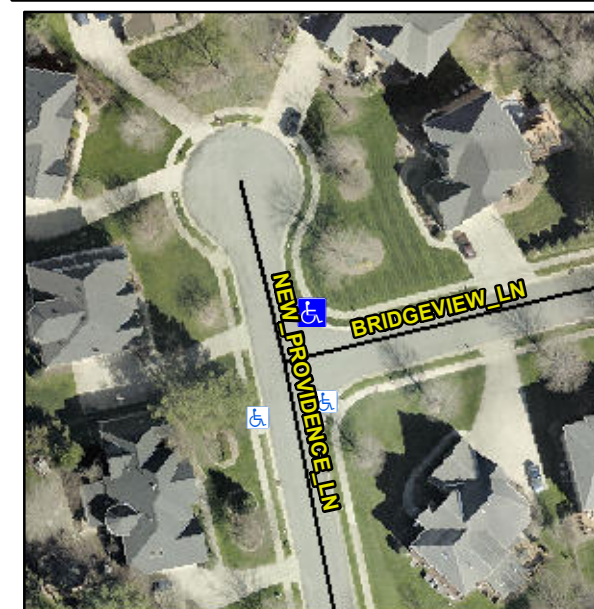
Compliance	Description	Data	Compliance	Description	Data
N/A	Ramp Length (in)	46.5	No	Ramp Slope (%)	8.5
No	Ramp Width (in)	44.0	No	Ramp XSlope (%)	4.2
N/A	Flare Type LT	N/A	N/A	Flare Type RT	N/A
N/A	Flare Slope LT (%)	N/A	N/A	Flare Slope RT (%)	N/A
N/A	Flare Traversable LT?	N/A	N/A	Flare Traversable RT?	N/A
N/A	Landing Length (in)	N/A	N/A	DWS Provided?	N/A
N/A	Landing Width (in)	N/A	N/A	DWS Contrast?	N/A
N/A	Landing Slope (%)	N/A	N/A	DWS Length (in)	N/A
N/A	Landing X Slope (%)	N/A	N/A	DWS Full Width?	N/A
N/A	Landing Curb? (Y/N)	N/A	N/A	DWS Offset (in)	N/A
N/A	Shared Landing?	N/A			
N/A	Gutter Ponding?	N/A	N/A	Gutter Slope (%)	N/A
N/A	Gutter Lip Ht (in)	N/A	N/A	Gutter X Slope (%)	N/A
N/A	Painted X Walk1?	No	N/A	Painted X Walk2?	No
	X Walk 1 Direction	To W		X Walk 2 Direction	To S
N/A	X Walk 1 Width (in)	N/A	N/A	X Walk 2 Width (in)	N/A
	X Walk 1 Slope (%)	1.4		X Walk 2 Slope (%)	4.2
	X Walk 1 X Slope (%)	5.7		X Walk 2 X Slope (%)	3.1

N/A	Ramp inside XWalk1?	N/A	N/A	Ramp inside XWalk2?	N/A
	Road Slope (%)	3.2	N/A	Clear Space?	N/A
	Road X Slope (%)	4.9	N/A	Clear Space to XWalk (in)	N/A
N/A	Any Obstructions?	N/A	N/A	Storm Grate/Utility Hazard?	N/A
	Obstruction Type			Storm Grate/Utility Type	
		N/A			N/A
			Yes	Surface Condition? (G/P)	Good

**Remove & Replace Curb Ramp With Two New Directional Ramps or Equivalent.**

**R304.5.1, R304.2.2, R304.5.3**
