Access Compliance Report

Public Rights-of-Way

(Curb Ramps)

Intersection ID: 10011027	Main Street: BLACKHAWK_RD	Cross Street: N/A	Location: S
ADA ID: E54B1683D276	Ramp Type: Perp	Initial Pass/Fail: Pass	Overall Compliance: No
Codes/Mitigation Info/Possible Solution		Field Measurements/Component Compliance

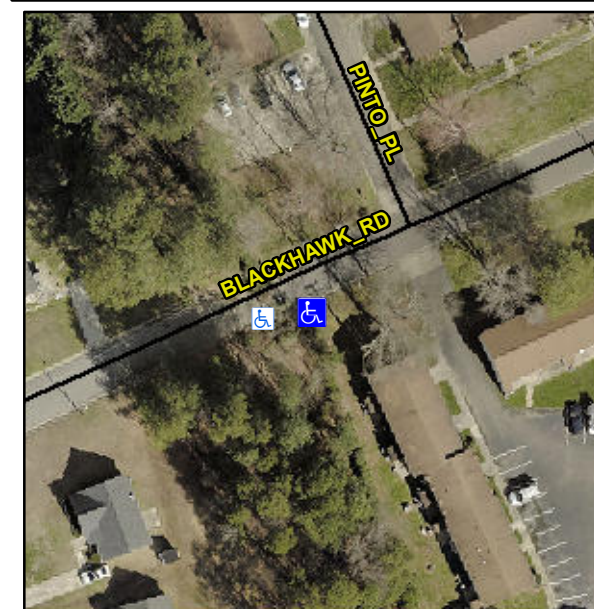
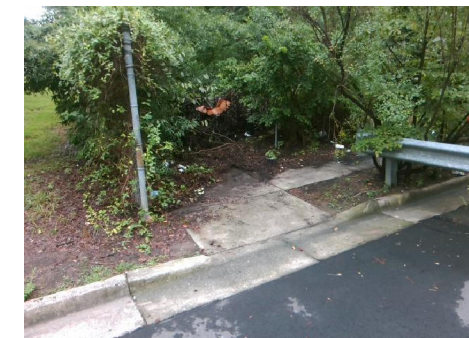
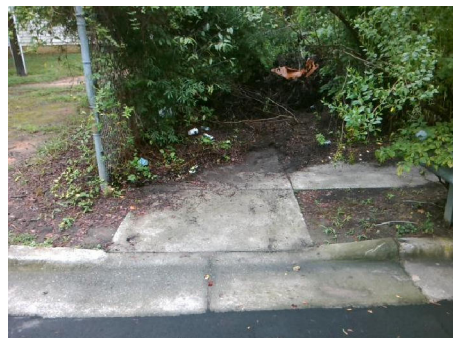
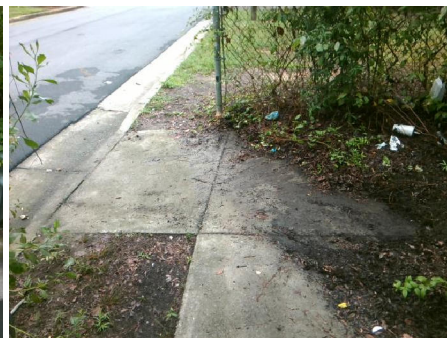
**Not Found, R304.5.3, R304.2.2-Perp,
R304.3.2-Para, R305, R302.7.2,
R304.5.4**

Compliance	Description	Data	Compliance	Description	Data
N/A	Ramp Length (in)	46.5	Yes	Ramp Slope (%)	5.4
Yes	Ramp Width (in)	73.0	No	Ramp XSlope (%)	3.5
N/A	Flare Type LT	None	N/A	Flare Type RT	N/A
N/A	Flare Slope LT (%)	N/A	N/A	Flare Slope RT (%)	N/A
N/A	Flare Traversable LT?	N/A	N/A	Flare Traversable RT?	N/A
Yes	Landing Length (in)	58.0	No	DWS Provided?	No
Yes	Landing Width (in)	71.0	N/A	DWS Contrast?	No
No	Landing Slope (%)	2.6	N/A	DWS Length (in)	N/A
Yes	Landing X Slope (%)	1.7	N/A	DWS Full Width?	No
N/A	Landing Curb? (Y/N)	No	N/A	DWS Offset (in)	N/A
N/A	Shared Landing?	No			
Yes	Gutter Ponding?	No	No	Gutter Slope (%)	6.0
No	Gutter Lip Ht (in)	1.0	Yes	Gutter X Slope (%)	0.2
N/A	Painted X Walk1?	No	N/A	Painted X Walk2?	N/A
	X Walk 1 Direction	To N		X Walk 2 Direction	N/A
N/A	X Walk 1 Width (in)	N/A	N/A	X Walk 2 Width (in)	N/A
	X Walk 1 Slope (%)	6.3		X Walk 2 Slope (%)	N/A
	X Walk 1 X Slope (%)	0.9		X Walk 2 X Slope (%)	N/A

N/A	Ramp inside XWalk1?	N/A	N/A	Ramp inside XWalk2?	N/A
	Road Slope (%)	N/A	N/A	Clear Space?	Yes
	Road X Slope (%)	N/A	N/A	Clear Space to XWalk (in)	N/A
Yes	Any Obstructions?	No	Yes	Storm Grate/Utility Hazard?	No
	Obstruction Type			Storm Grate/Utility Type	
			N/A		N/A
			Yes	Surface Condition? (G/P)	Good

Possible Solutions:

**Remove & Replace Entire Ramp.
Remove & Replace Gutter.**
