Access Compliance Report

Public Rights-of-Way

(Curb Ramps)

Intersection ID: 32217	Main Street: REAVENCREST_PARK_DR	Cross Street: BRYANT_FARMS_RD	Location: S
ADA ID: E54B511E76AB	Ramp Type: Perp	Initial Pass/Fail: Fail	Overall Compliance: No
Codes/Mitigation Info/Possible Solution		Field Measurements/Component Compliance	
Severity Score: 26.25

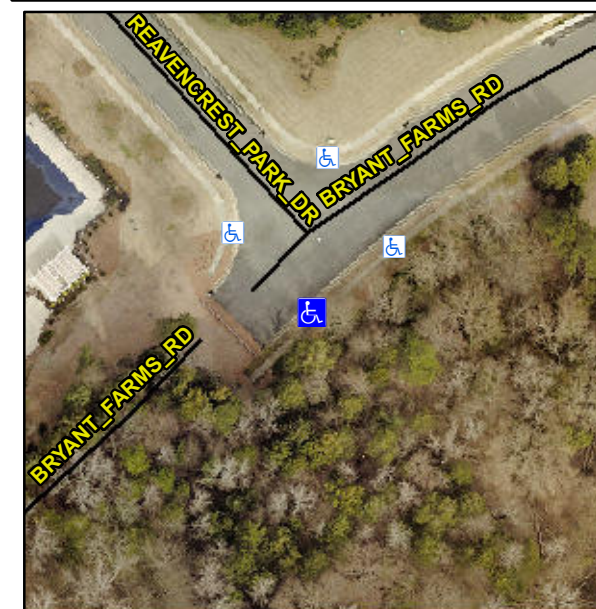
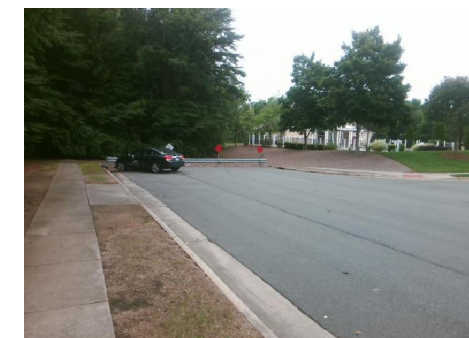
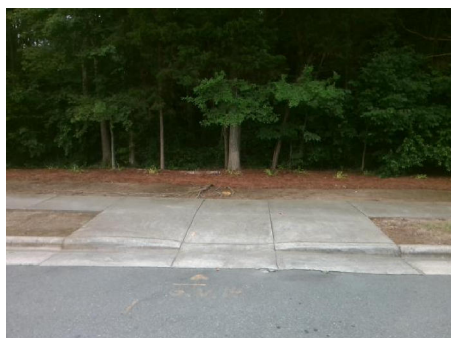
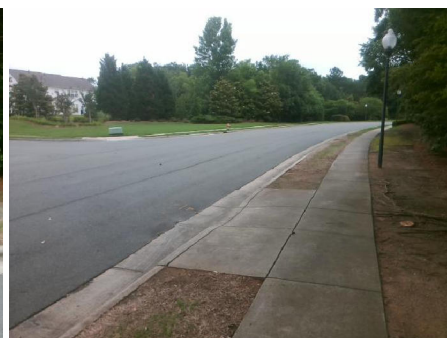
Not Found, R304.2.2, R304.5.3

Compliance	Description	Data	Compliance	Description	Data
N/A	Ramp Length (in)	51.0	No	Ramp Slope (%)	12.6
Yes	Ramp Width (in)	54.0	No	Ramp XSlope (%)	3.2
N/A	Flare Type LT	N/A	N/A	Flare Type RT	N/A
N/A	Flare Slope LT (%)	N/A	N/A	Flare Slope RT (%)	N/A
N/A	Flare Traversable LT?	N/A	N/A	Flare Traversable RT?	N/A
N/A	Landing Length (in)	N/A	N/A	DWS Provided?	N/A
N/A	Landing Width (in)	N/A	N/A	DWS Contrast?	N/A
N/A	Landing Slope (%)	N/A	N/A	DWS Length (in)	N/A
N/A	Landing X Slope (%)	N/A	N/A	DWS Full Width?	N/A
N/A	Landing Curb? (Y/N)	N/A	N/A	DWS Offset (in)	N/A
N/A	Shared Landing?	N/A			
N/A	Gutter Ponding?	N/A	N/A	Gutter Slope (%)	N/A
N/A	Gutter Lip Ht (in)	N/A	N/A	Gutter X Slope (%)	N/A
N/A	Painted X Walk1?	No	N/A	Painted X Walk2?	N/A
	X Walk 1 Direction	To NW		X Walk 2 Direction	N/A
N/A	X Walk 1 Width (in)	N/A	N/A	X Walk 2 Width (in)	N/A
	X Walk 1 Slope (%)	1.7		X Walk 2 Slope (%)	N/A
	X Walk 1 X Slope (%)	2.5		X Walk 2 X Slope (%)	N/A

N/A	Ramp inside XWalk1?	N/A	N/A	Ramp inside XWalk2?	N/A
	Road Slope (%)	N/A	N/A	Clear Space?	N/A
	Road X Slope (%)	N/A	N/A	Clear Space to XWalk (in)	N/A
N/A	Any Obstructions?	N/A	N/A	Storm Grate/Utility Hazard?	N/A
	Obstruction Type			Storm Grate/Utility Type	
		N/A			N/A
			Yes	Surface Condition? (G/P)	Good

Remove & Replace Entire Ramp.

Total Cost: \$ 1850.00
